Device Errata

Skywire[®] Raspberry Pi Adapter

NimbeLink Corp

Updated: July 2017

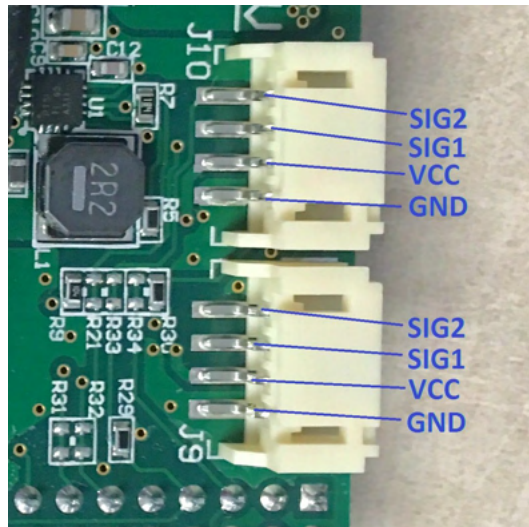
Applications using the Grove connectors on NL-AB-RPI adapter board with PCB revision 1001430 REV A are affected. The grove connector pins are reversed, as shown in the image below. Users who wish to use Grove sensors on affected PCBs must follow the steps outlined in section four of this errata.

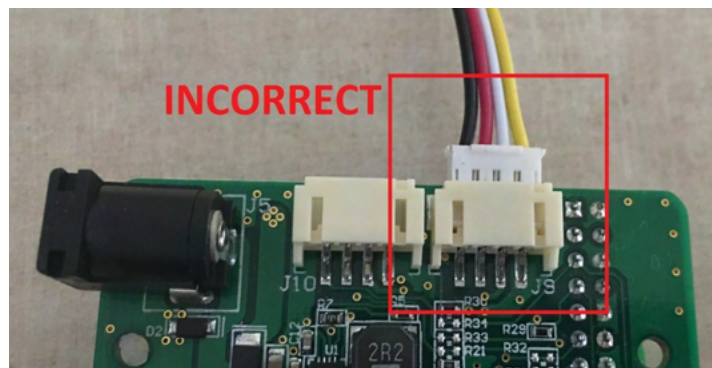
Grove sensors using unmodified cables should not be directly attached to the Grove connectors on affected boards as this may cause shorts and/or damage to the sensor or Raspberry Pi.

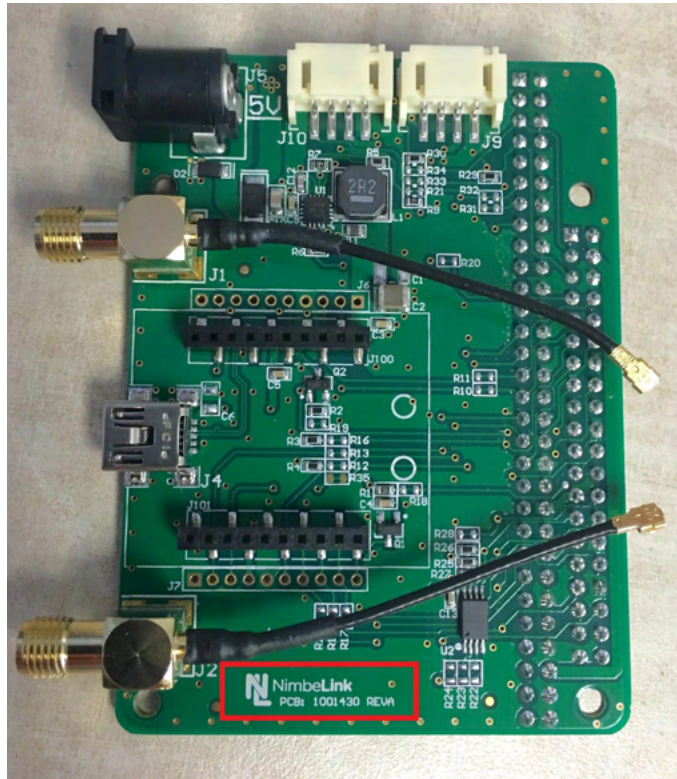
The PCB revision number is located on the bottom of the top side of the PCB. This Errata affects all NL-AB-RPI boards with a PCB revision number of 1001430 Rev A.
