Environmental Tests on Multimax 5g Antennas

For	Airgain Inc 3611 Valley Centre Dr Ste 150 San Diego, CA 92130
P.O. Number	4000078529
Date Tested	December 15, 2022 to December 22, 2022
Test Personnel	Kyle Hewitt
Test Documents	ISO 20653 (2013-02-15) Customer Provided Document "SOW Multimax 5G IP67 & IP69K rev. 1.1"

Elite Electronic Engineering Inc.

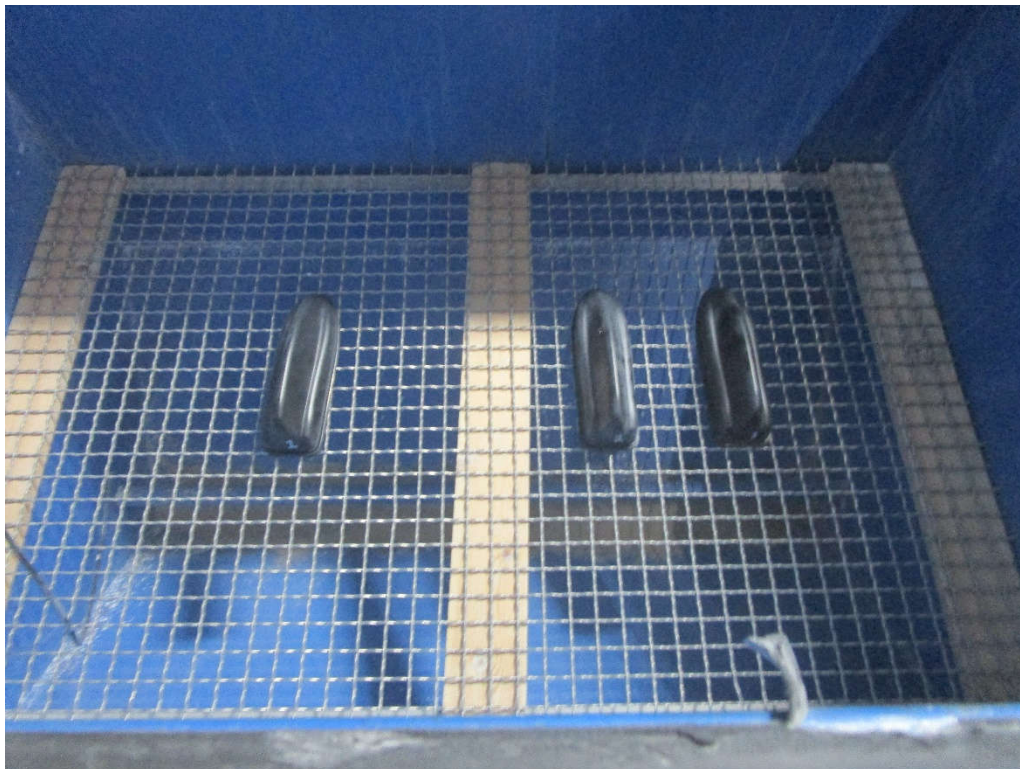
Test Setup Photograph

The test was conducted in accordance with ISO 20653 (2013-02-15) IP6K, and Customer Provided Document "SOW Multimax 5G IP67 and IP69K rev. 1.1". The DUTs were then placed inside the chamber.

The dust used was A2 Arizona dust. A 1mm diameter wire, 100mm long, was then used to probe all openings or seams on each DUT.

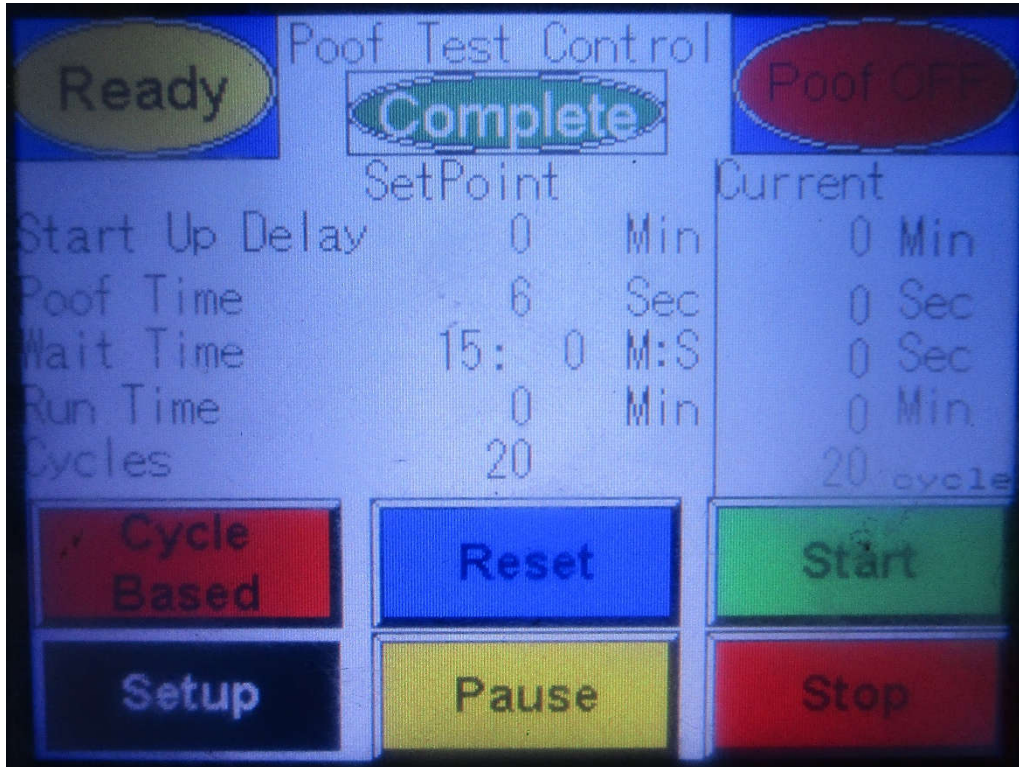
Completed Profile

The chamber conditions were maintained for a period of five (5) hours at ambient room temperature. The dust was agitated for six (6) seconds every 15 minutes for a total duration of 5 hours (20 cycles). The chamber temperature, duration and dust density were adjusted as follows:

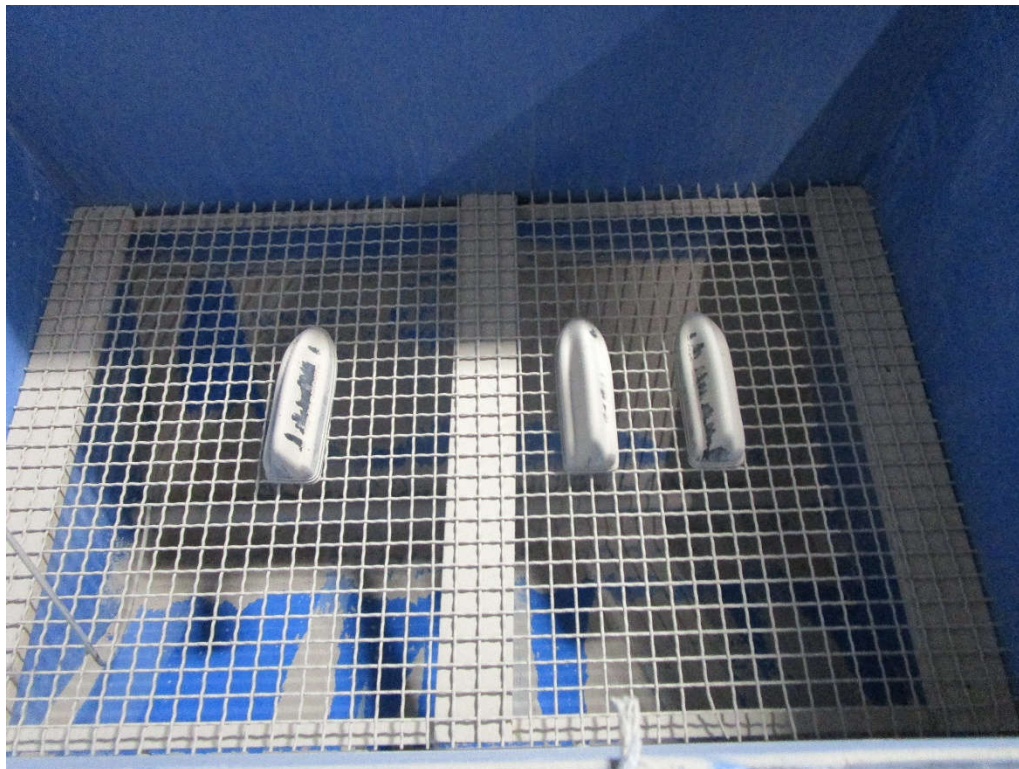
Post-Test Photograph

The DUTs completed the Dust testing per ISO 20653 (2013-02-15) IP6K, and Customer Provided Document "SOW Multimax 5G IP67 and IP69K rev. 1.1". Following the test, the DUTs were visually inspected for physical damage and dust intrusion. The DUTs had no evidence of physical damage or dust intrusion and were not penetrated by the wire probe. The DUTs were then returned to the customer for further evaluation.

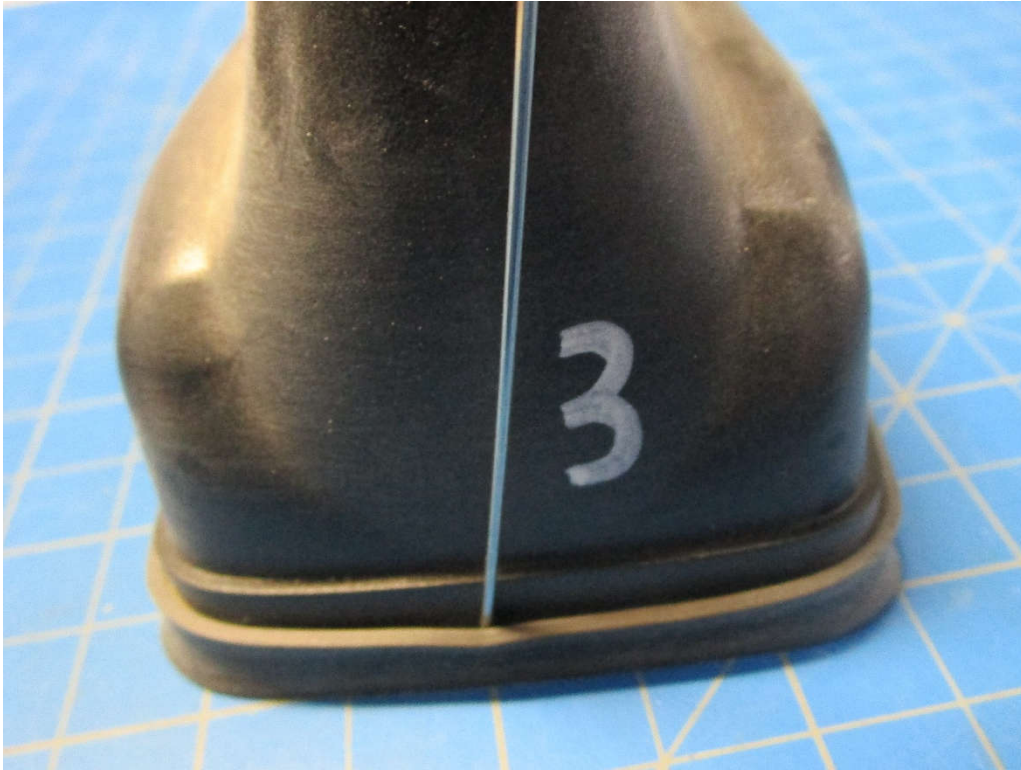
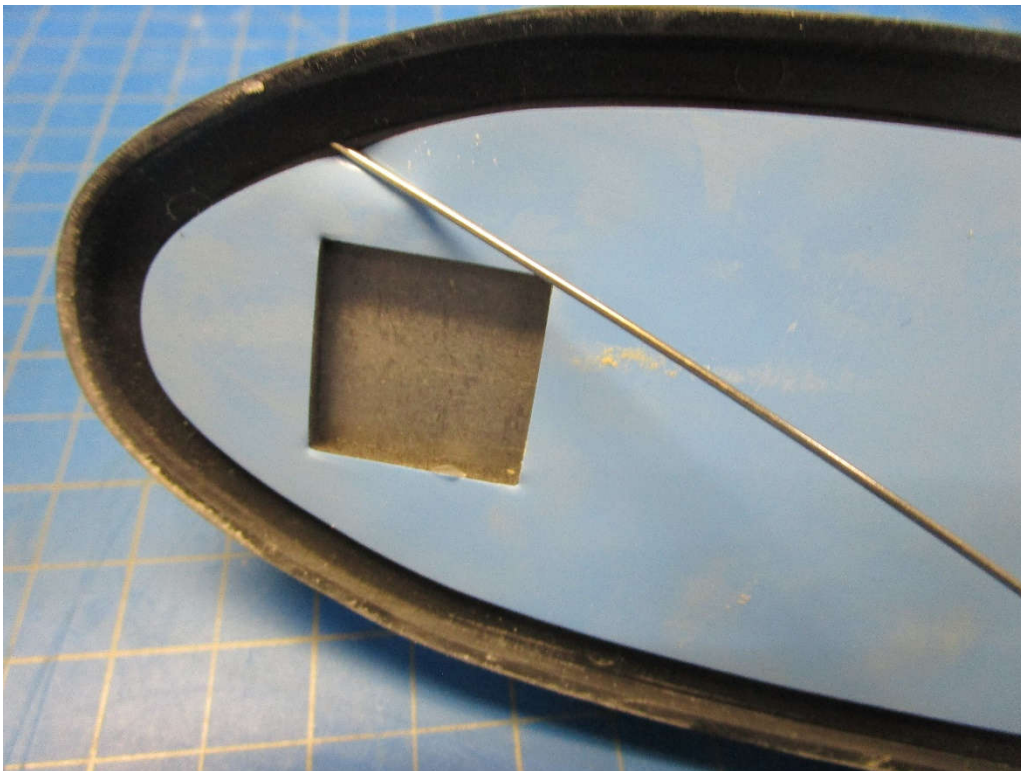
Test In Progress Photographs– 1mm Probe

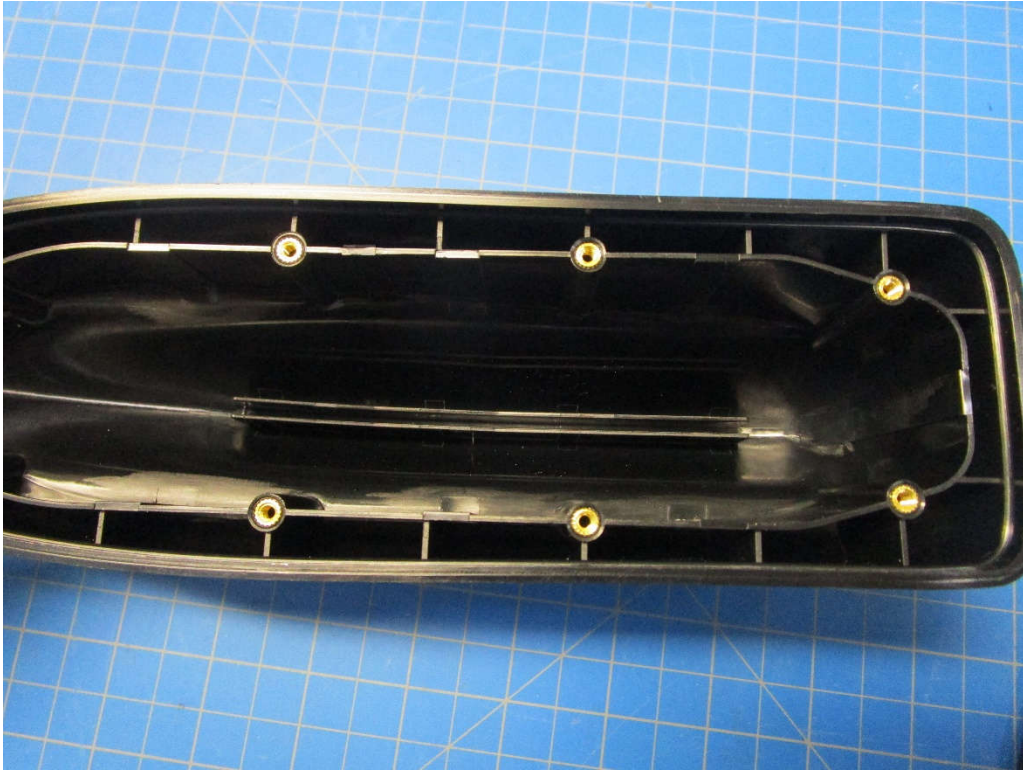
Typical Post-Test Photograph – DUT Interior

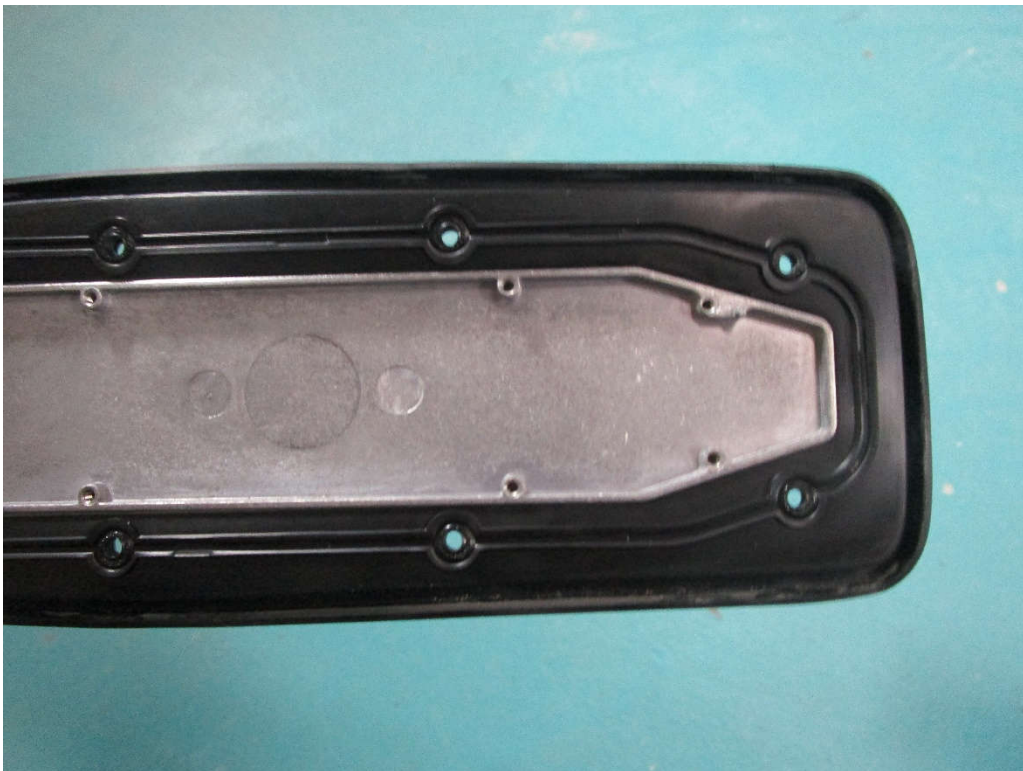
Typical Post-Test Photograph – DUT Base

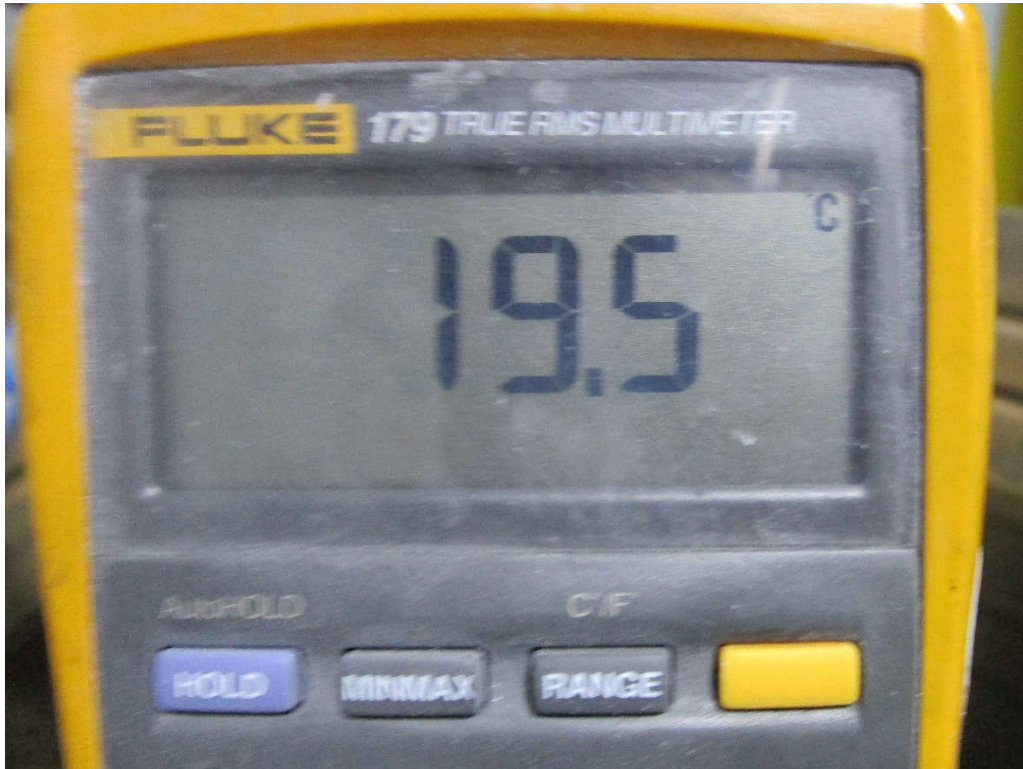
Test Setup Photograph – Water Temperature

The DUTs were then submerged in water. The lowest point on the sample was located 1,000 millimeters below the surface of the water. The DUTs remained submerged for thirty (30) minutes. The water in the tank was at room ambient conditions and did not differ by more than 5°C of the DUT temperature. The DUTs were inspected for evidence of water intrusion after the exposure to the immersion test.

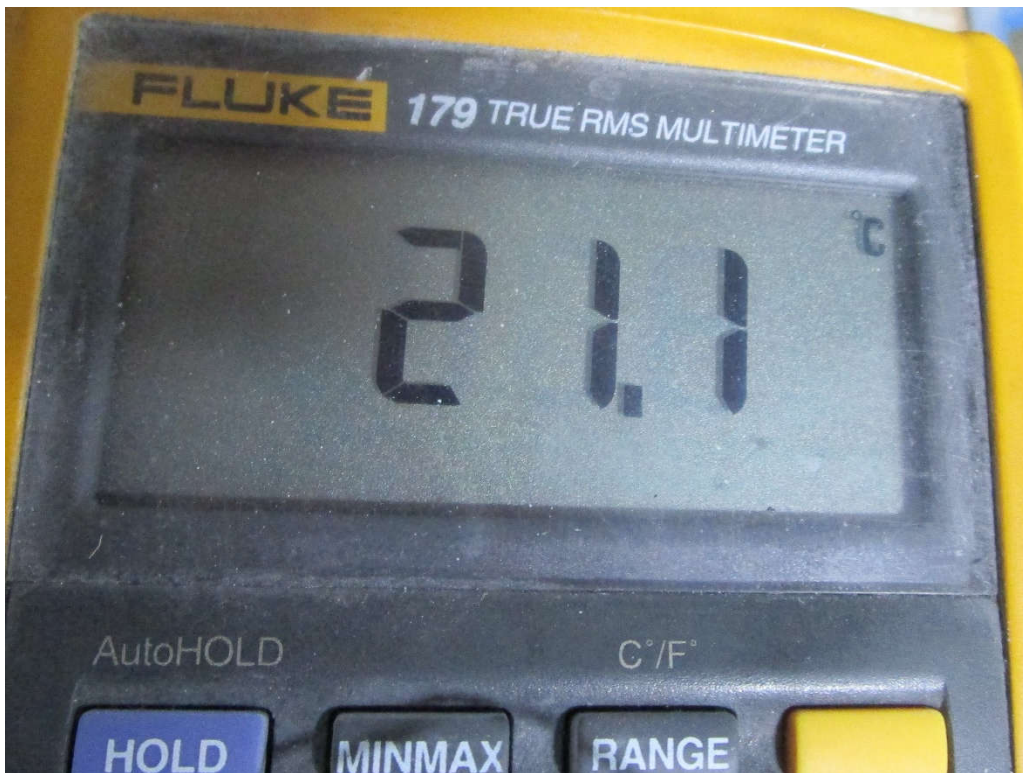
Test Setup Photograph – DUT Temperature

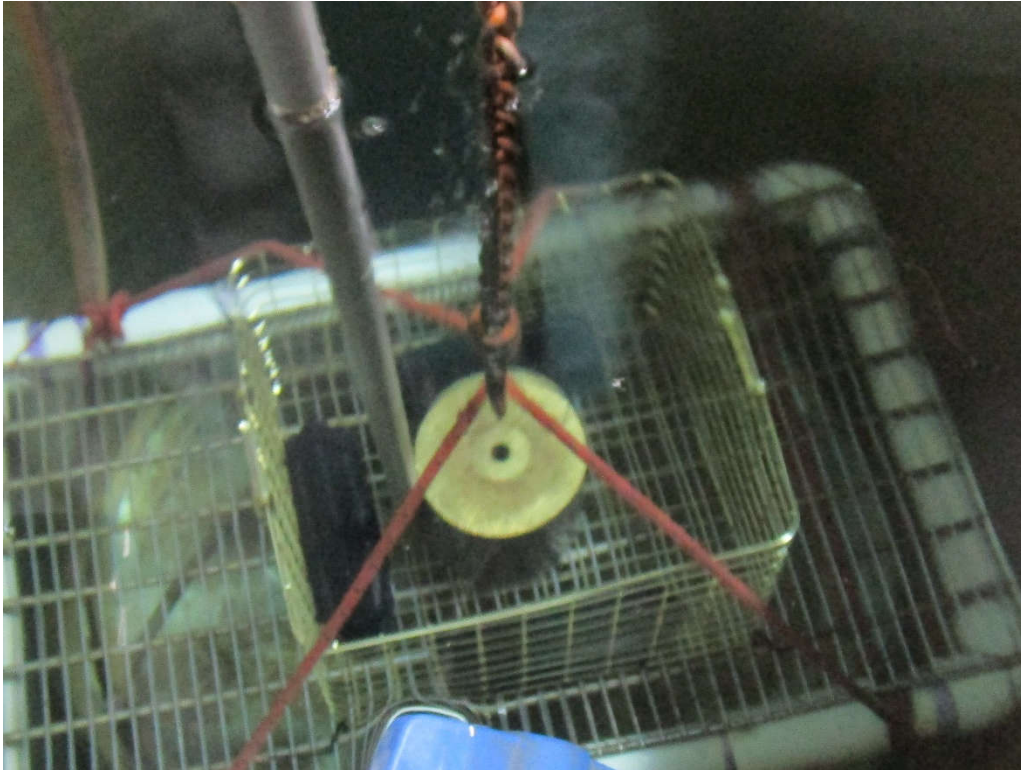
Test In Progress Photograph

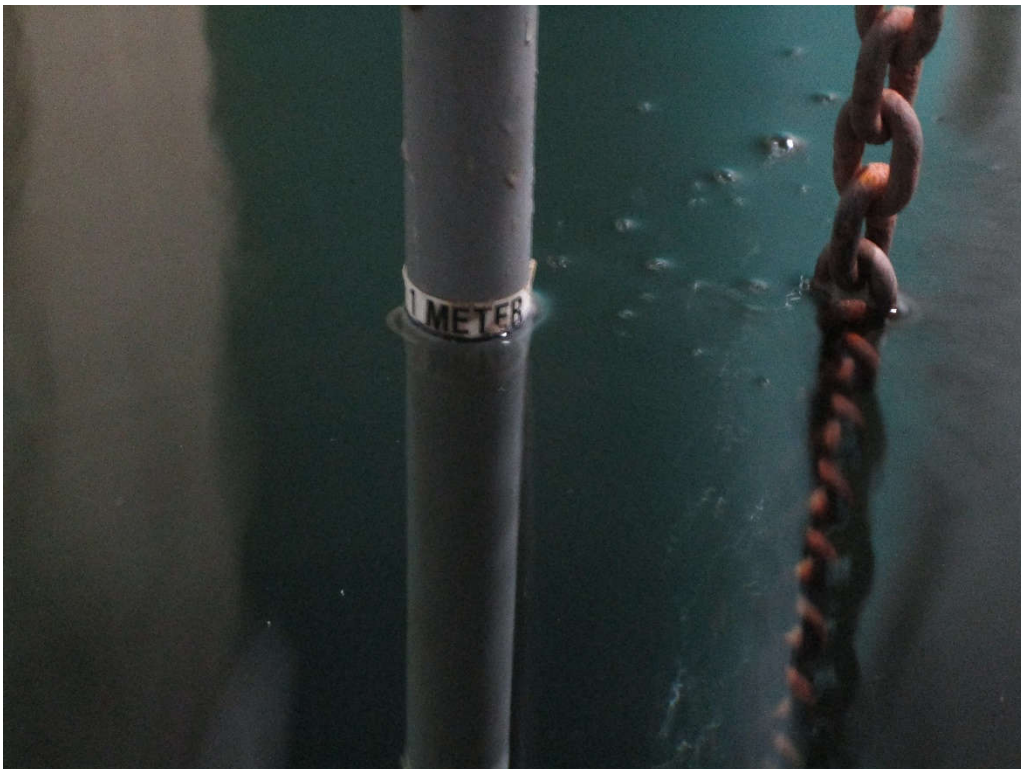
Test In Progress Photograph – Depth Measurement

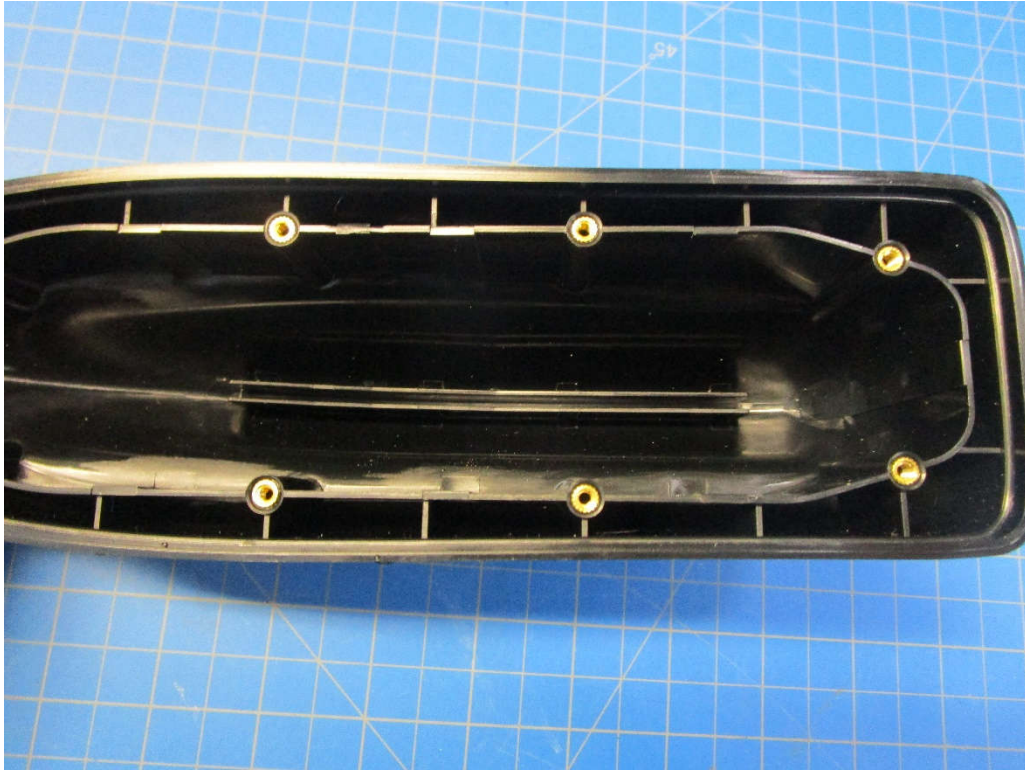
Typical Post-Test Photograph – DUT Interior

The DUTs were subjected to and completed the Immersion testing per ISO 20653 (2013-02-15) IPX7, and Customer Provided Document "SOW Multimax 5G IP67 and IP69K rev. 1.1". There was no evidence of water intrusion after the thirty (30) minutes of immersion. Following the test, the DUTs were returned to the customer for further inspection.

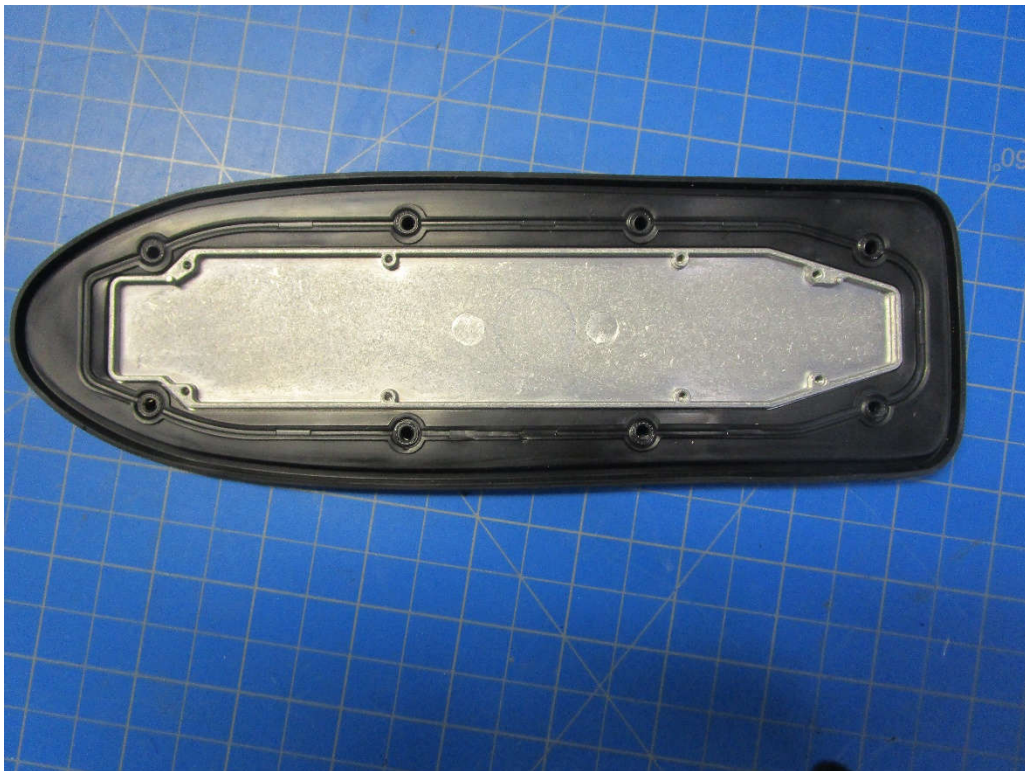
Typical Post-Test Photograph – DUT Base

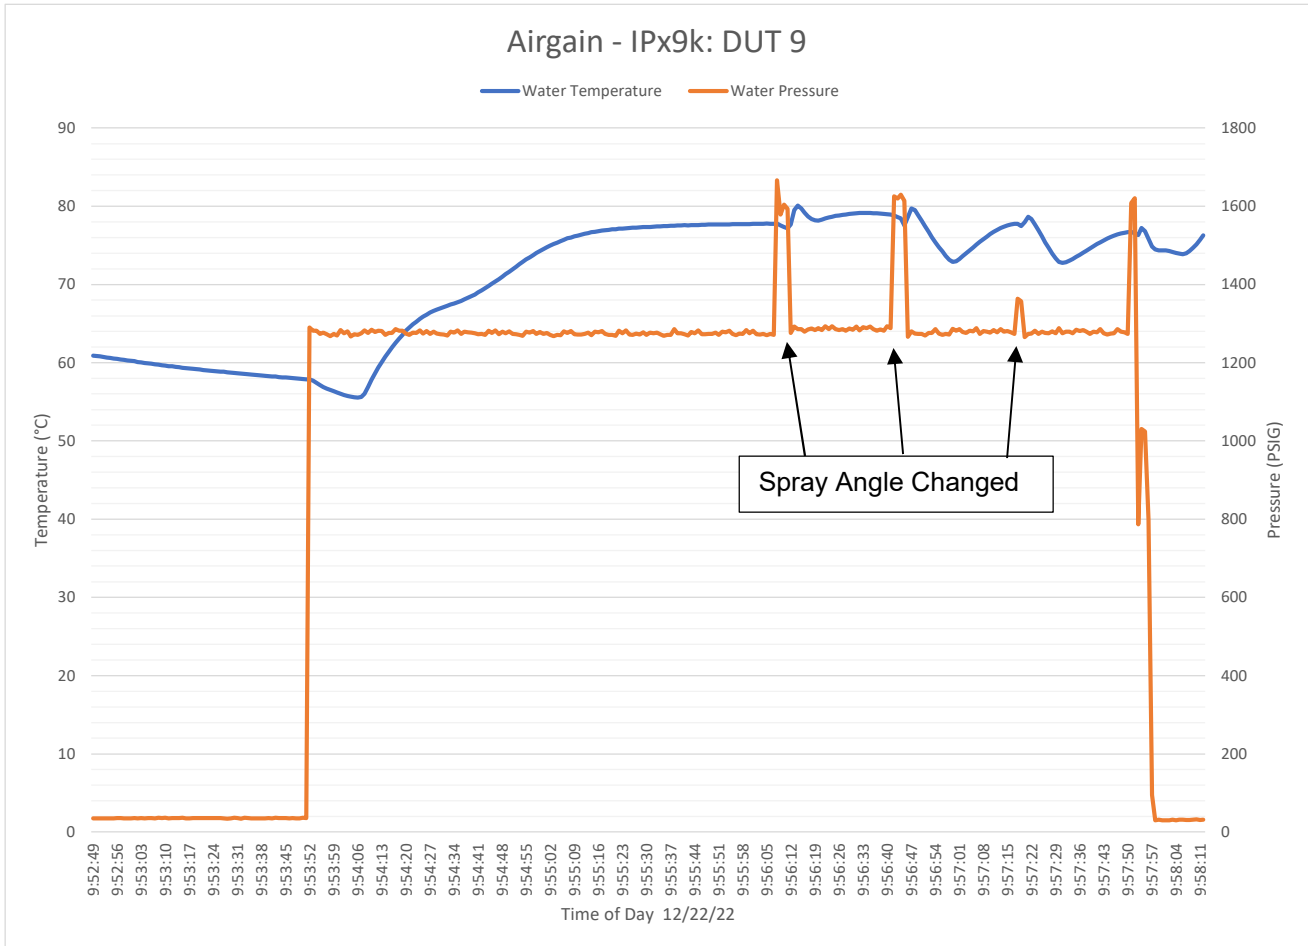
Typical Pressure/Temperature Plot

The DUTs were then subjected to water spray from a distance of 100 to 150 mm (4 - 6 inches). The water was sprayed through a 35° (±5°) fan nozzle at a pressure of 8,000kPa to 10,000kPa (1160PSI to 1450PSI) with a flow rate of 3.69GPM to 4.22GPM (13.9 Liters/Minute to 15.9 Liters/Minute). The water was heated and maintained at a temperature of 80°C ± 5°C throughout the entire exposure. The DUTs were subjected to the water spray for a period of 30 seconds per position (90°, 60°, 30°, 0°) with the DUTs rotating at 5 rpm for a total exposure of 2 minutes. Following the exposure, the DUTs were visually inspected for physical damage and water intrusion.

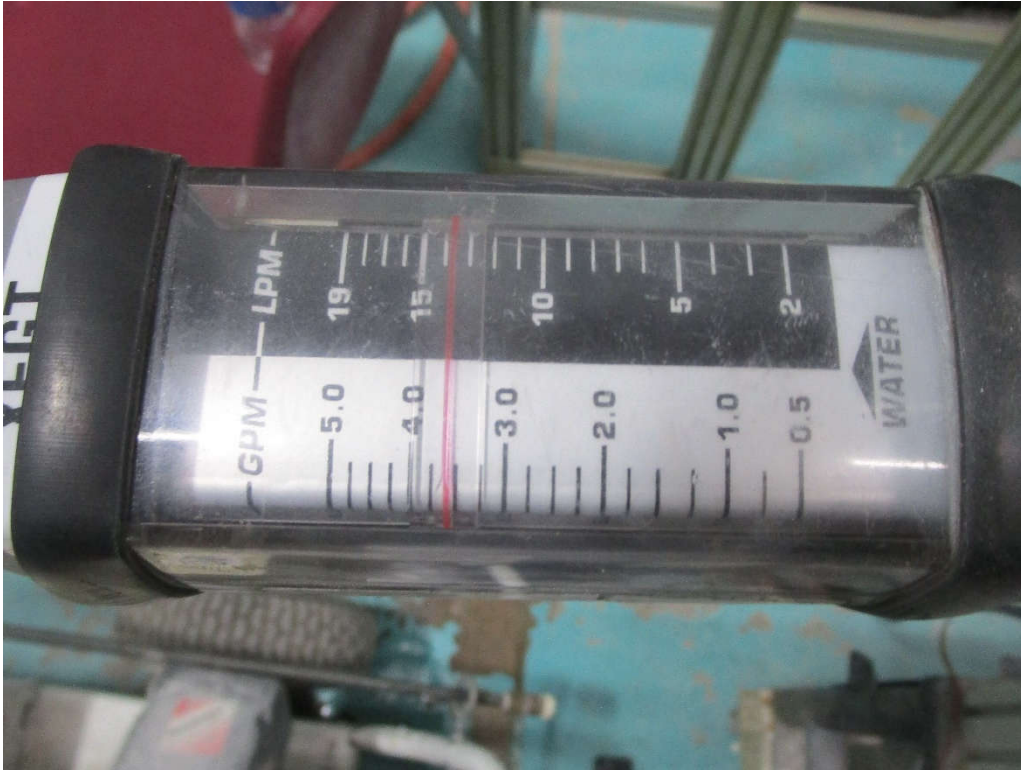
Test Setup Photograph (Flow)

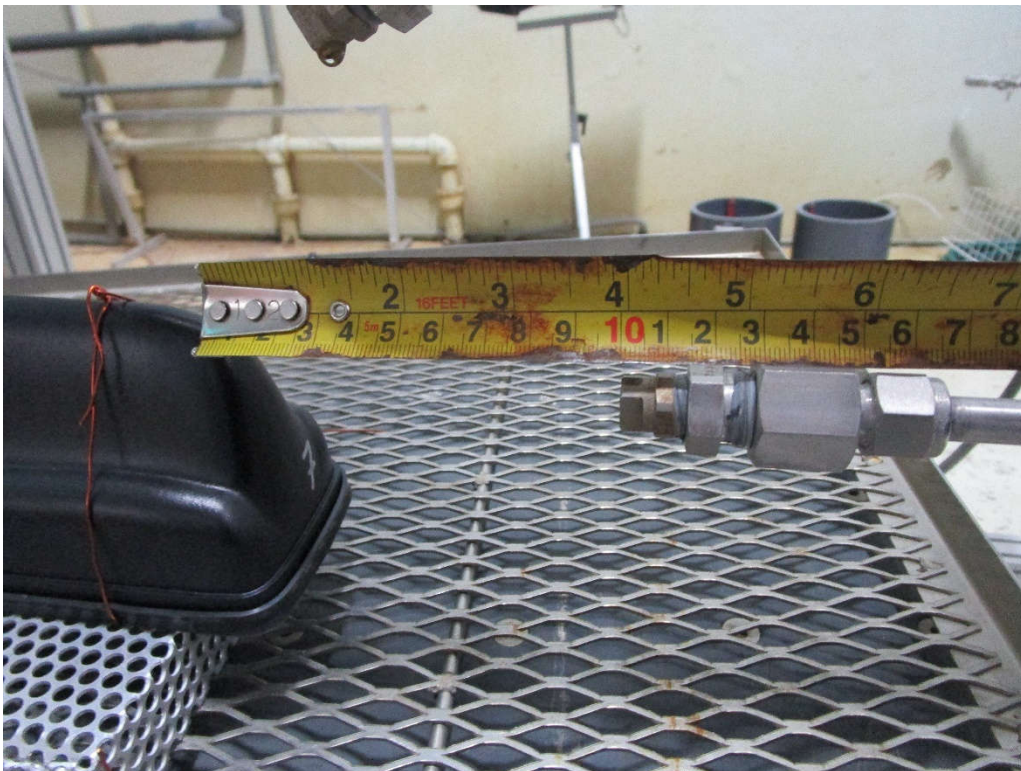
Test Setup Photograph (Distance - 0°)

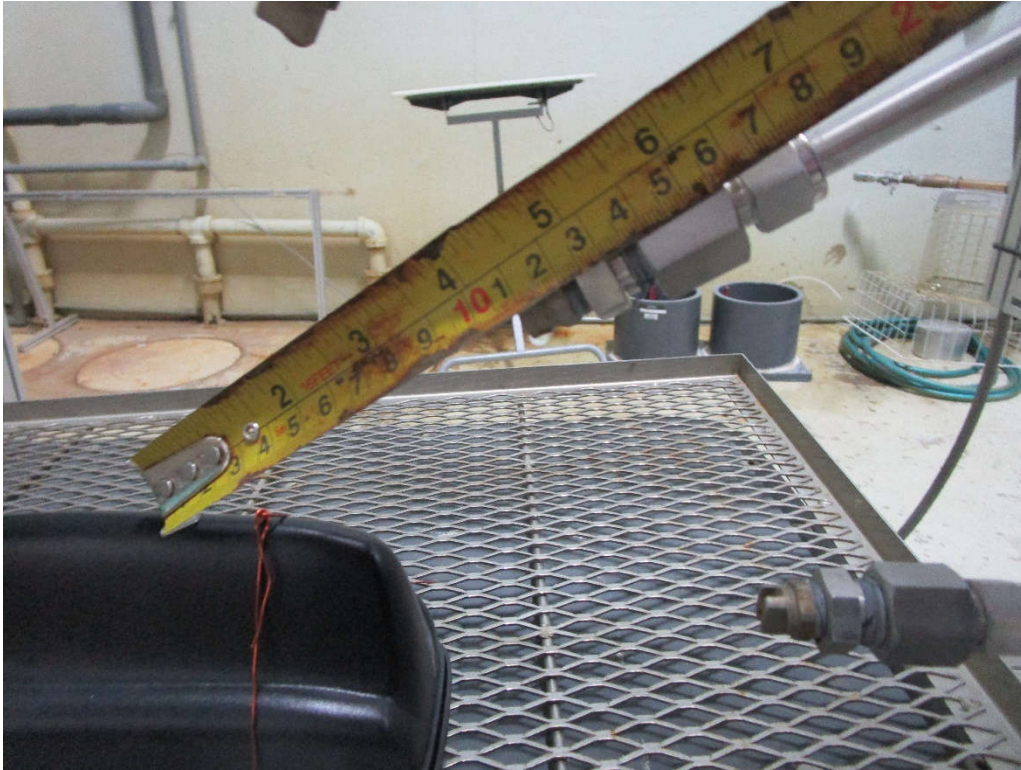
Test Setup Photograph (Distance - 30°)

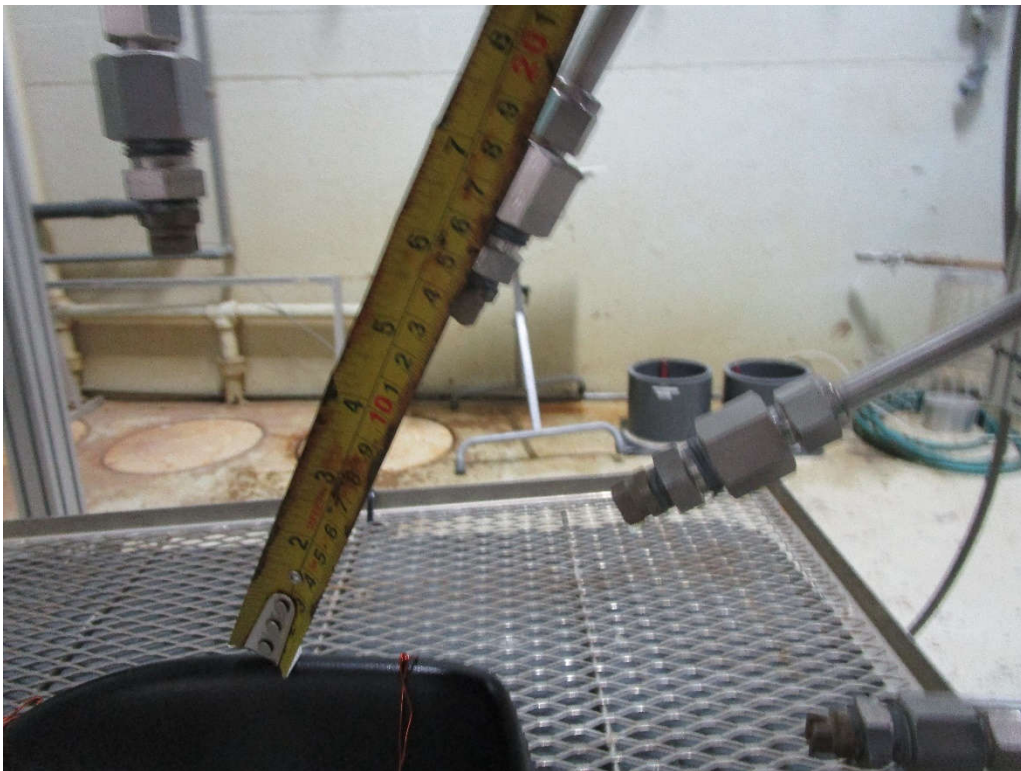
Test Setup Photograph (Distance - 60°)

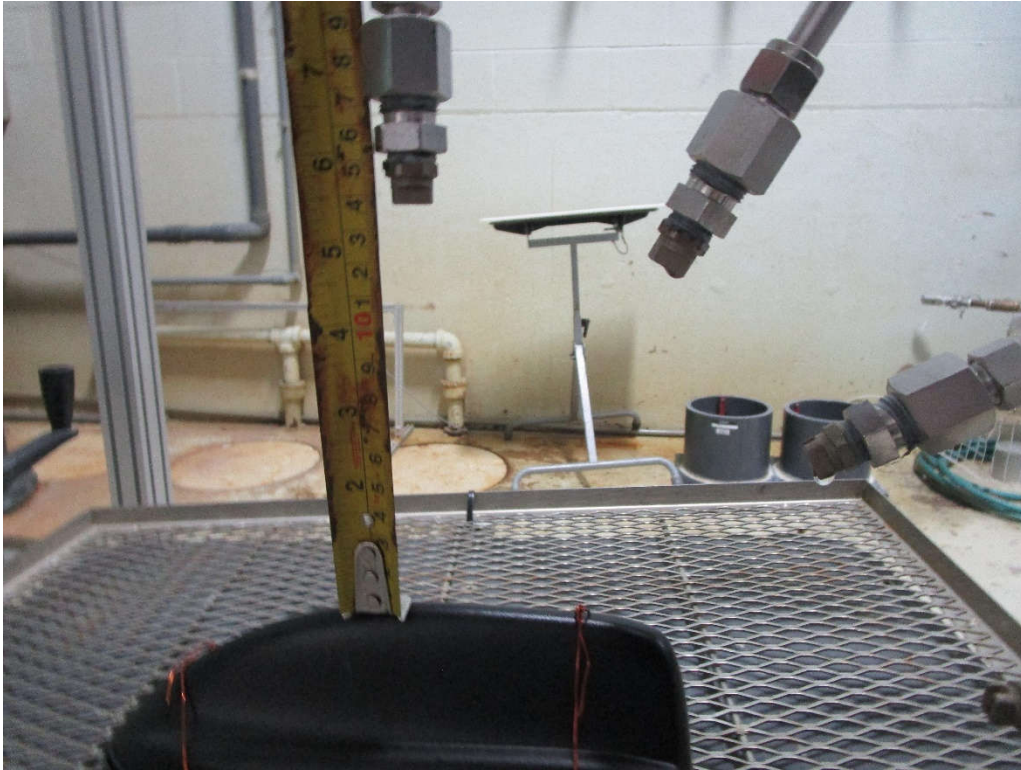
Test Setup Photograph (Distance - 90°)

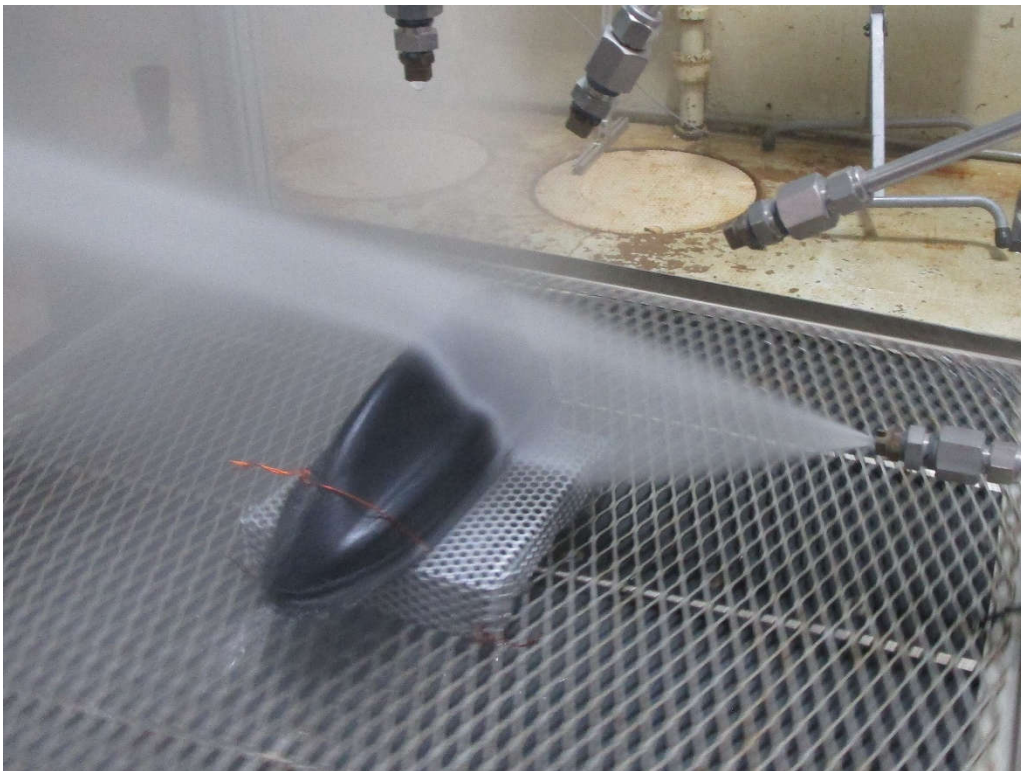
Test in Progress Photograph (0°)

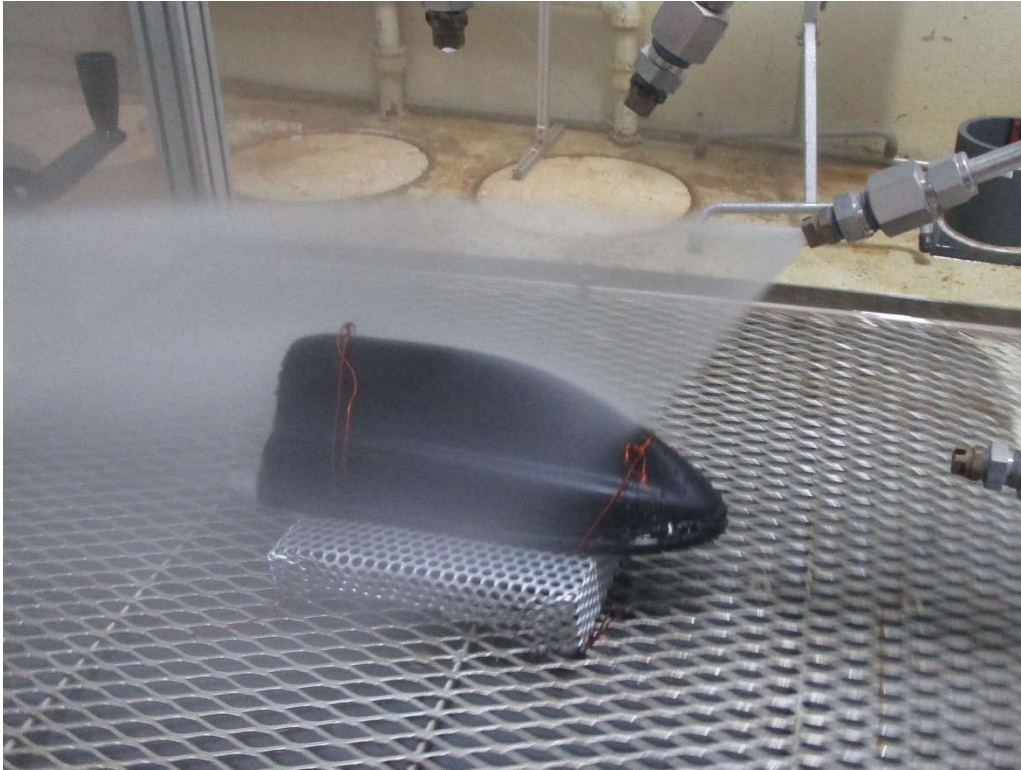
Test in Progress Photograph (30°)

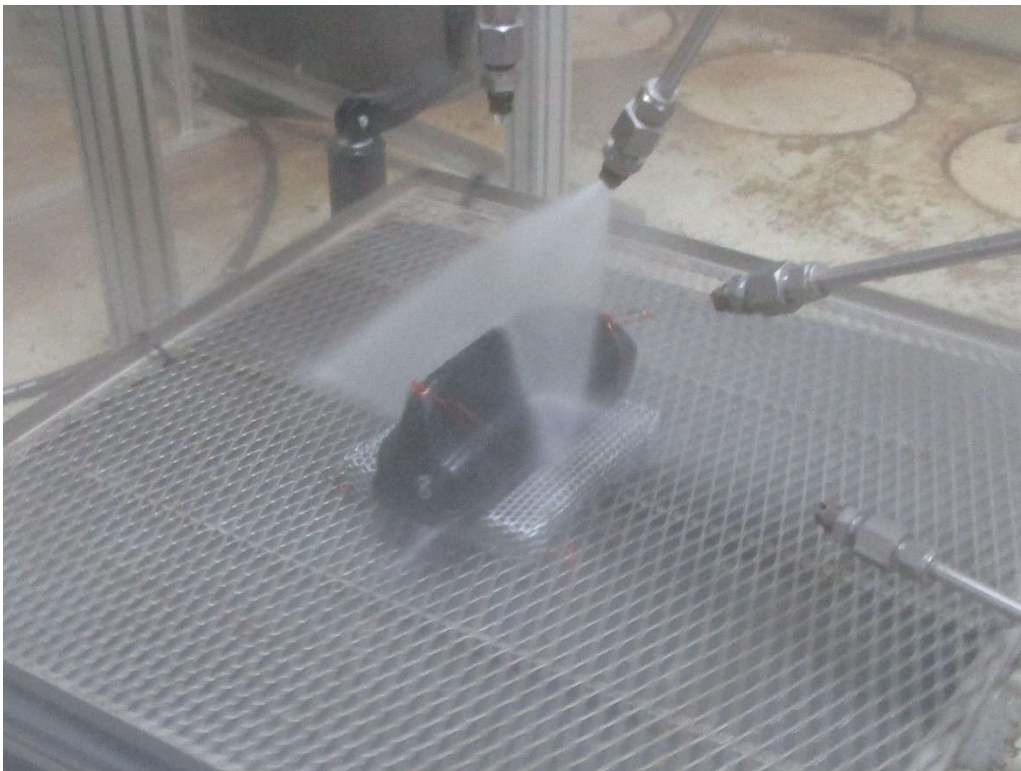
Test in Progress Photograph (60°)

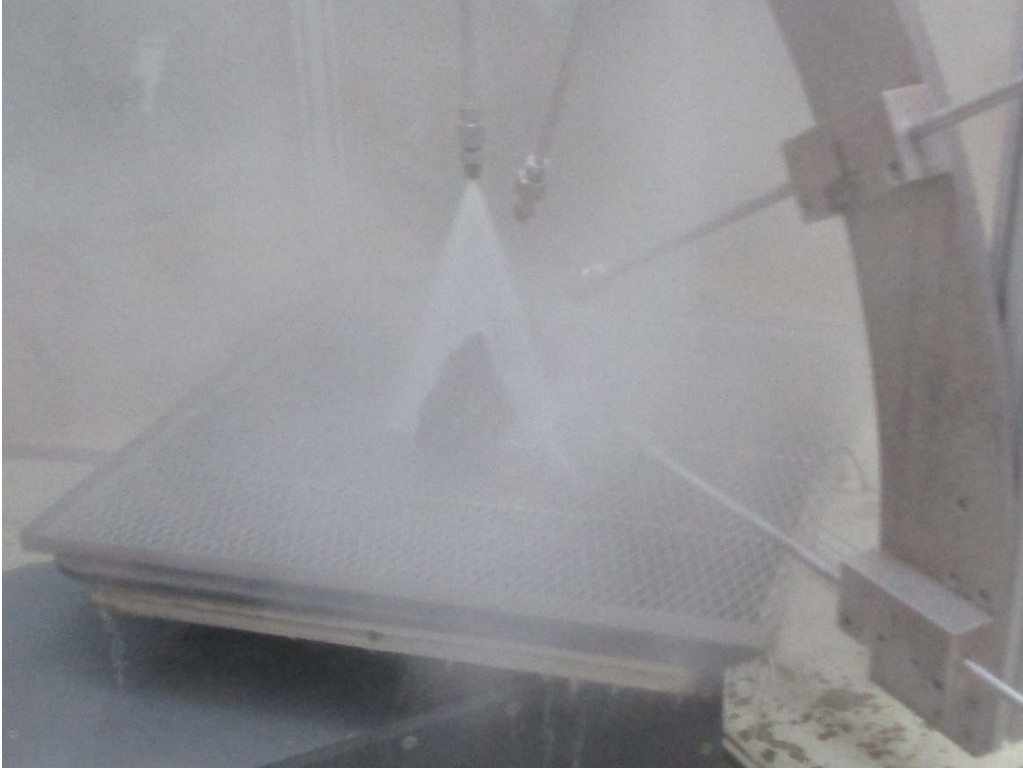
Test in Progress Photograph (90°)

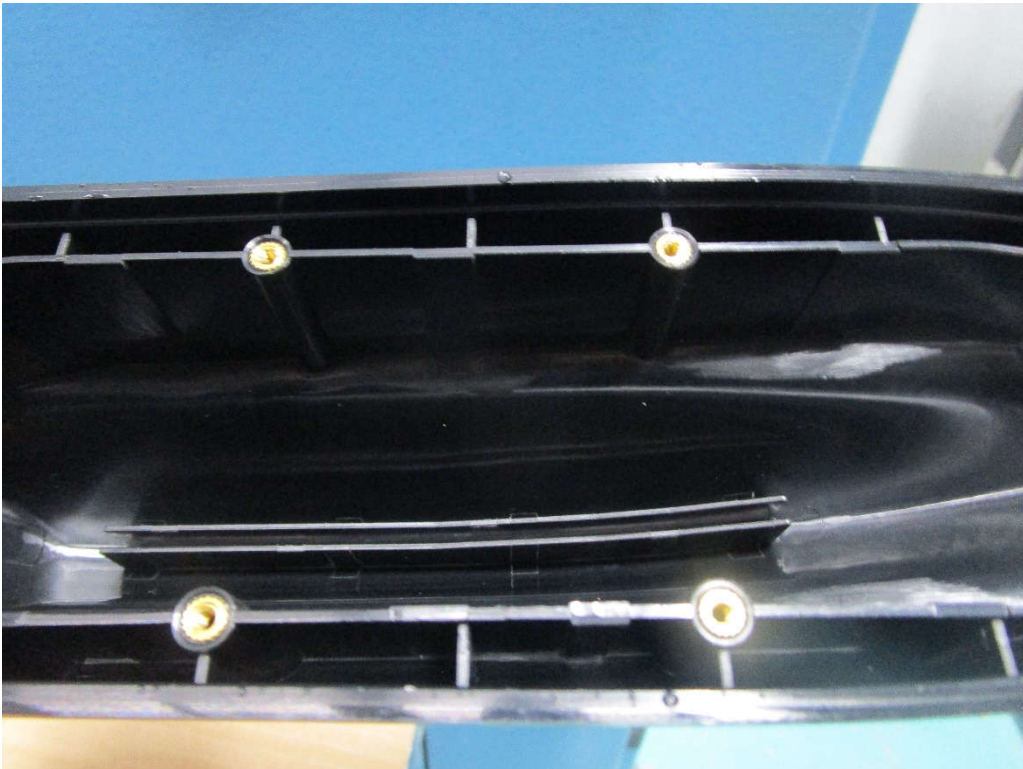
Typical Post-Test Photograph – DUT Interior

The DUTs were subjected to and completed the Pressure Spray testing per ISO 20653 (2013-02-15) IPx9K, and Customer Provided Document "SOW Multimax 5G IP67 and IP69K rev. 1.1". Following the test, the DUTs were visually inspected for physical damage or water intrusion. The DUTs had no evidence of physical damage or water intrusion. The DUTs were then returned to the customer for further evaluation.

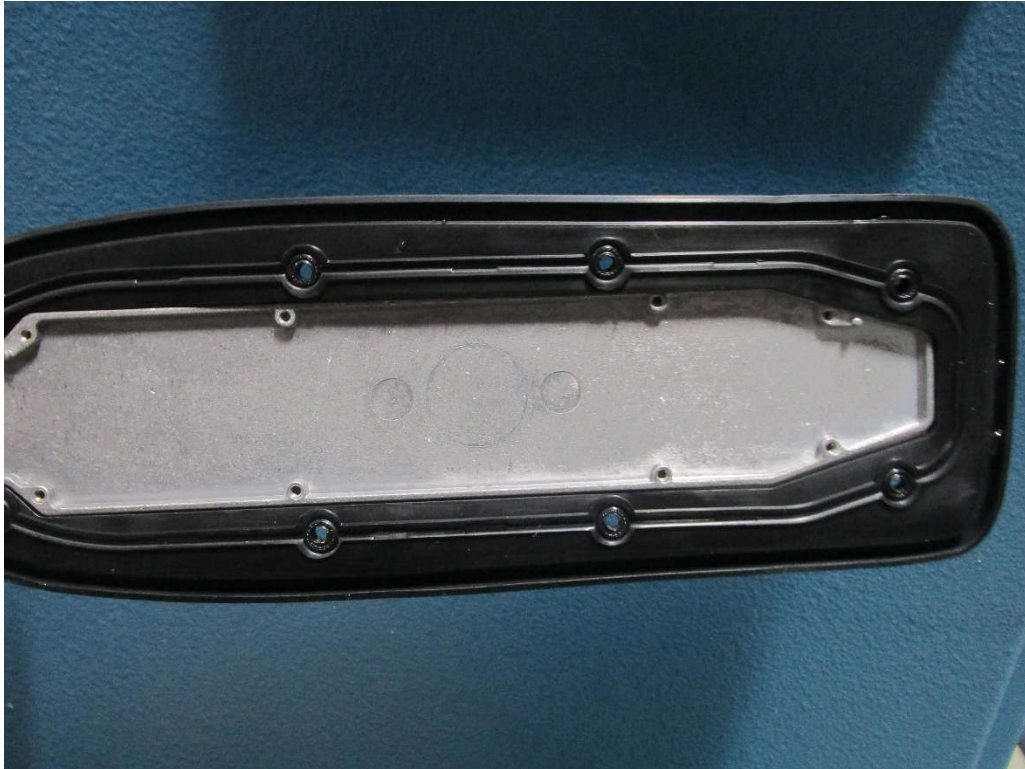
Typical Post-Test Photograph – DUT Base
