Environmental Tests on NPD MM5G

For	Airgain Inc 7860 E McClain Dr Ste 2 Scottsdale, AZ 85260
P.O. Number	4000078977
Date Tested	June 5, 2023 to June 7, 2023
Test Personnel	Kyle Hewitt, Michael Tegeler
Test Specification	ISO 20653 (2013-02-15)

2. INTRODUCTION

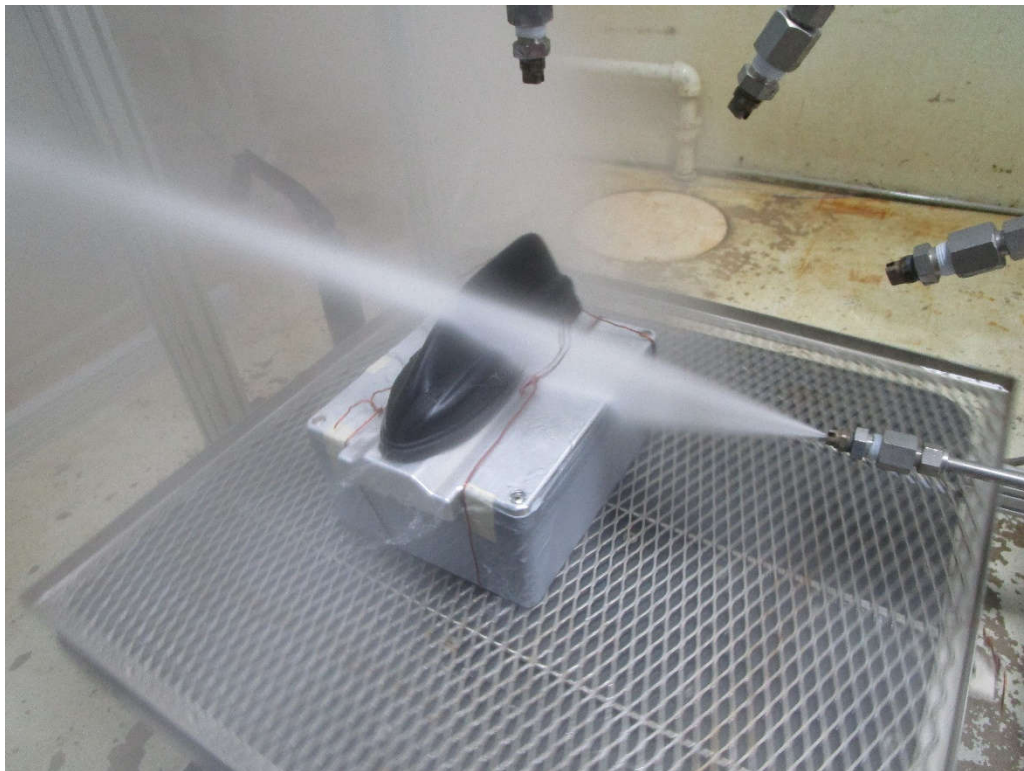
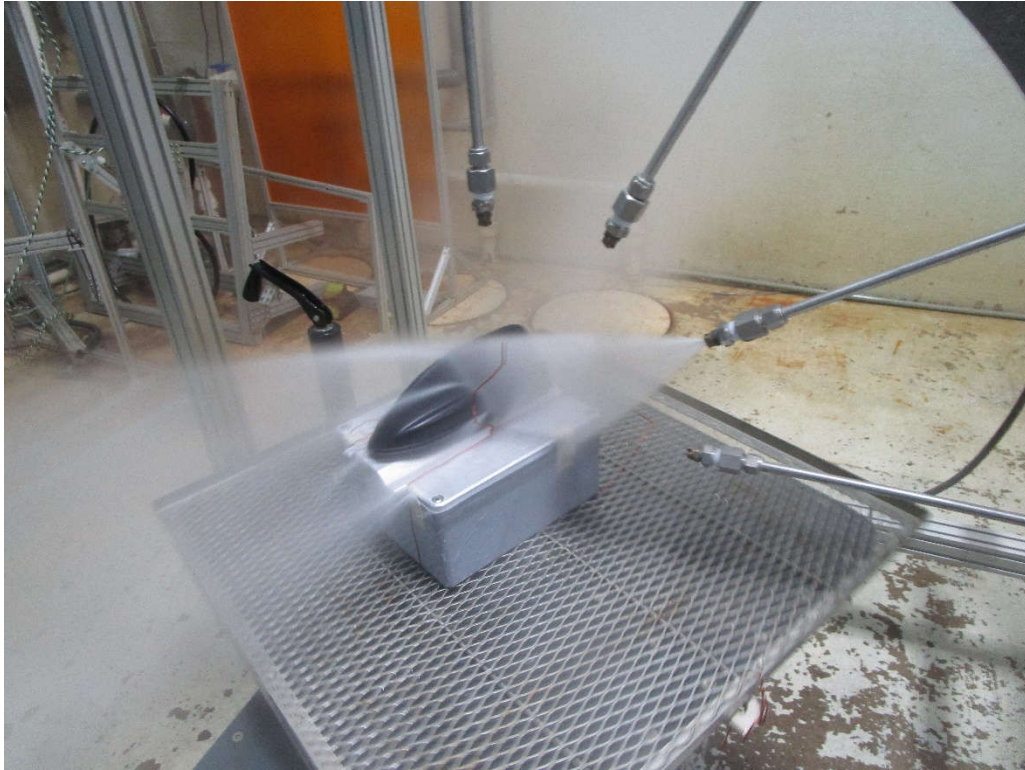
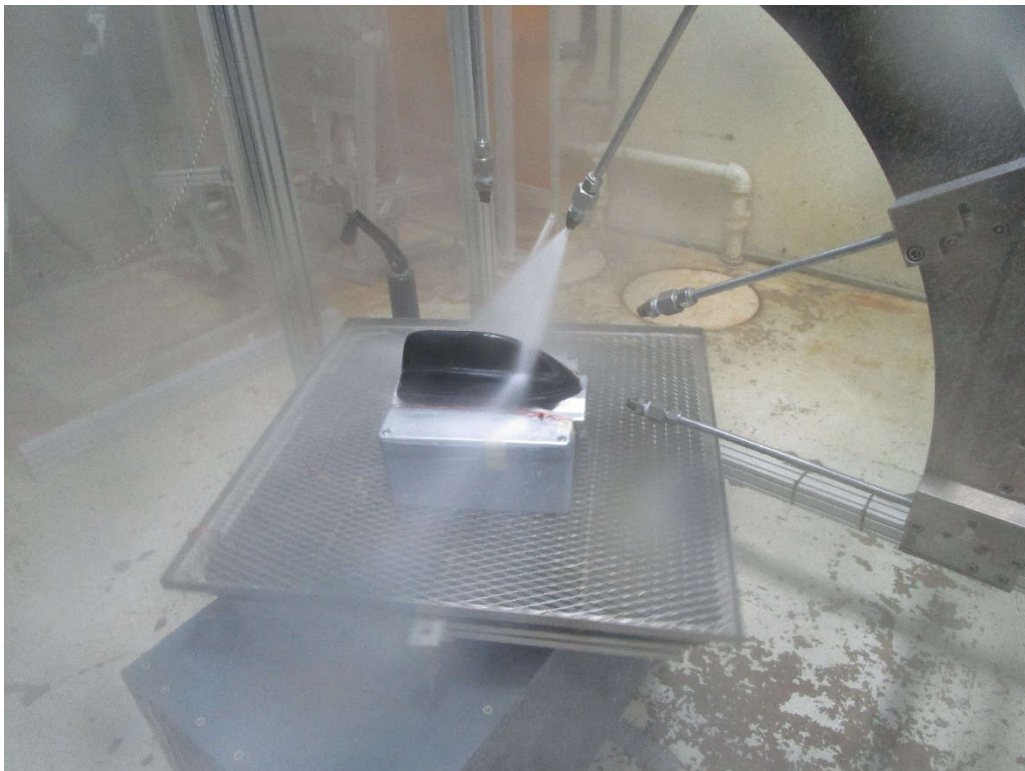
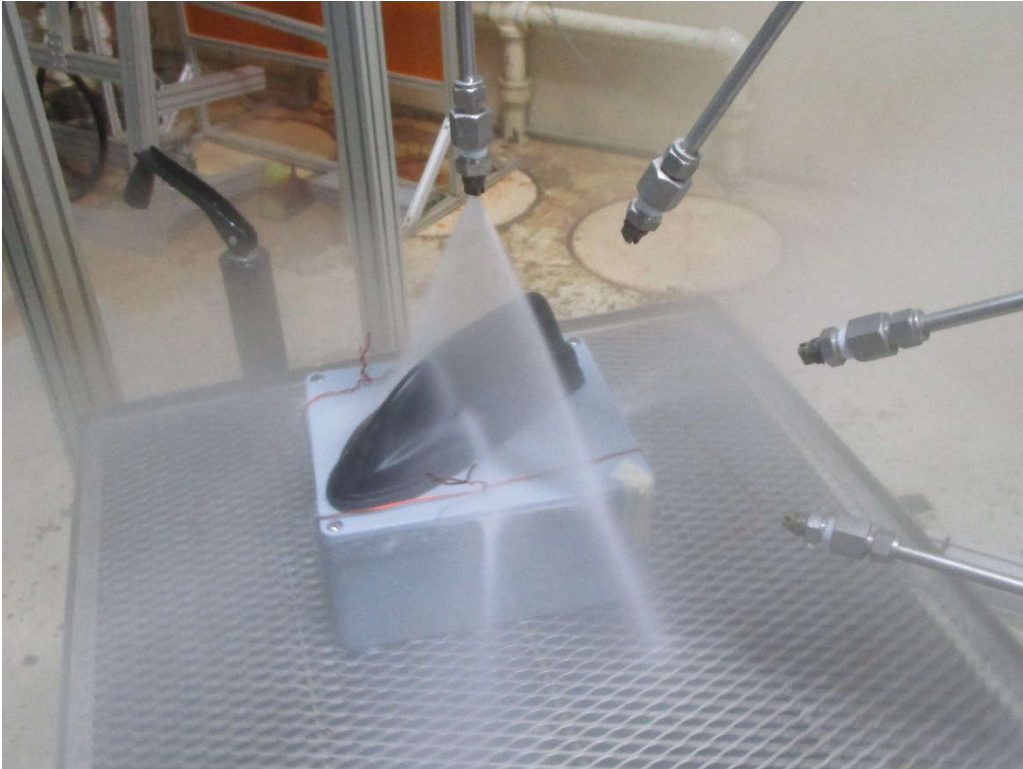
Test in Progress Photograph (0°)

Test in Progress Photograph (30°)

Test in Progress Photograph (60°)

Test in Progress Photograph (90°)

The DUTs were then subjected to water spray from a distance of 100 to 150 mm (4-6 inches). The water was sprayed through a 35° (±5°) fan nozzle at a pressure of 8,000kPa to 10,000kPa (1160PSI to 1450PSI) with a flow rate of 3.69GPM to 4.22GPM (14 Liters/Minute to 16 Liters/Minute). The water was heated and maintained at a temperature of 80°C ± 5°C throughout the entire exposure. The DUTs were subjected to the water spray for a period of 30 seconds per position (90°, 60°, 30°, 0°) with the DUTs rotating at 5 rpm for a total exposure of 2 minutes. Following the exposure, the DUTs were visually inspected for physical damage and water intrusion.
