TEST REPORT

Company : Airgain, Inc
Address : 3611 Valley Centre Drive, Ste. 150, San Diego, CA 92130 USA
Sample Name : AirgainConnect Fleet
Model Name : AirgainConnect Fleet
Date Received : FEB 06, 2024
Date Tested : FEB 06, 2024 ~ FEB 09, 2024

2. DUST TEST

3. HIGH PRESSURE WASH TEST

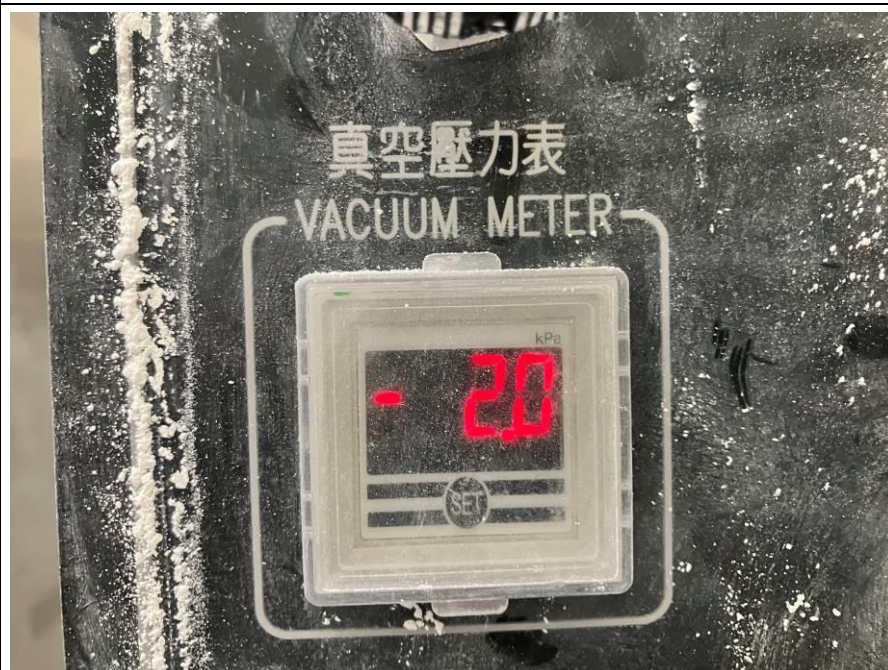
3131

Depression level

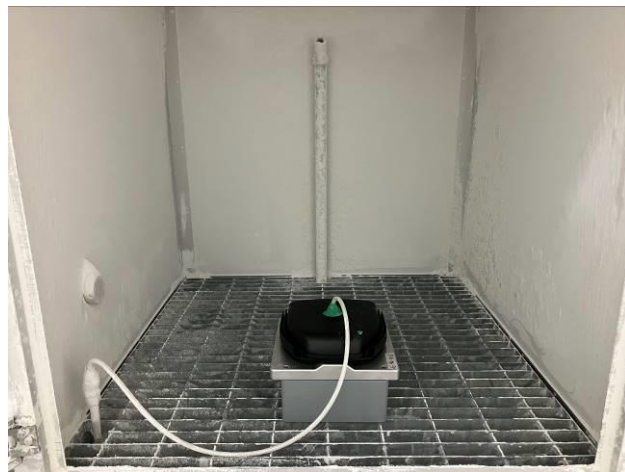
3131

Setup for before test

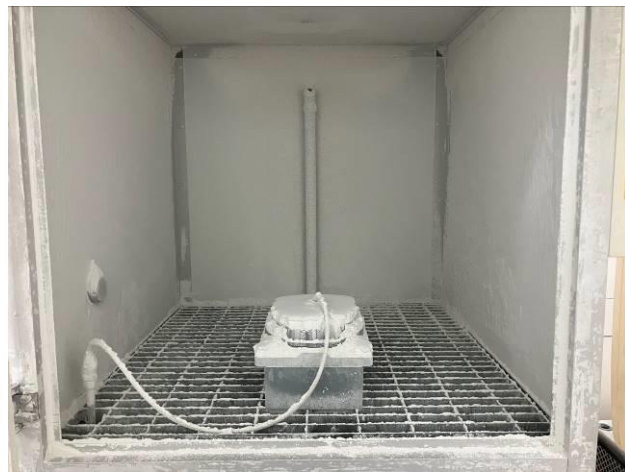
Setup for after test

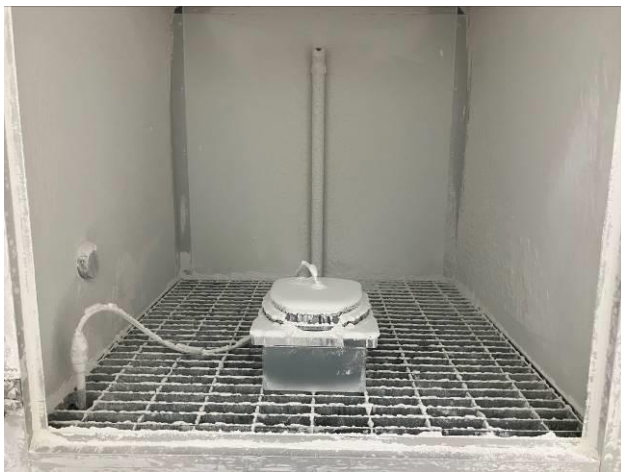
Setup for after test

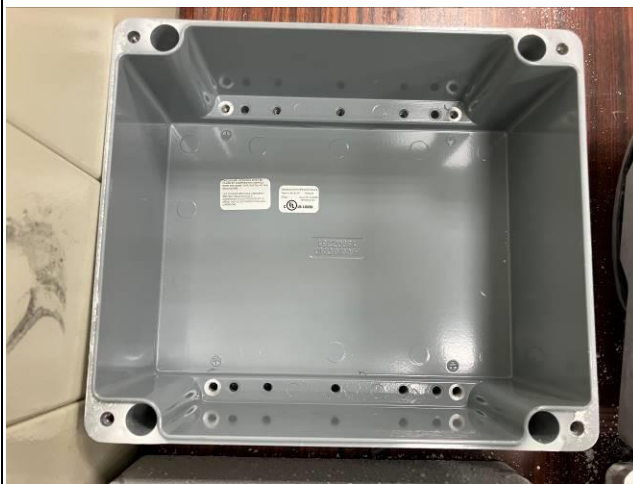
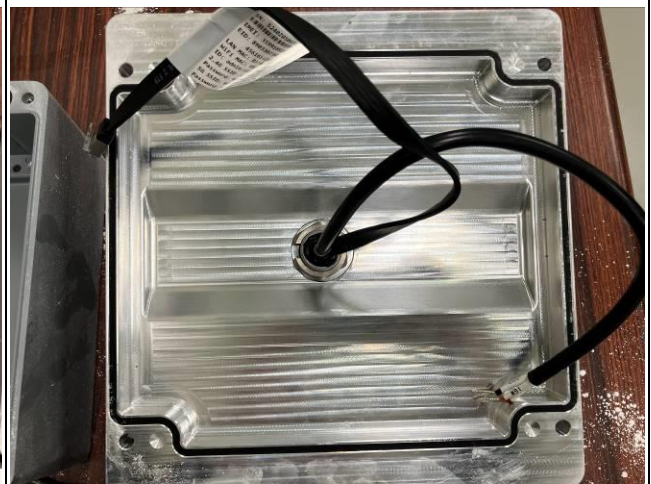
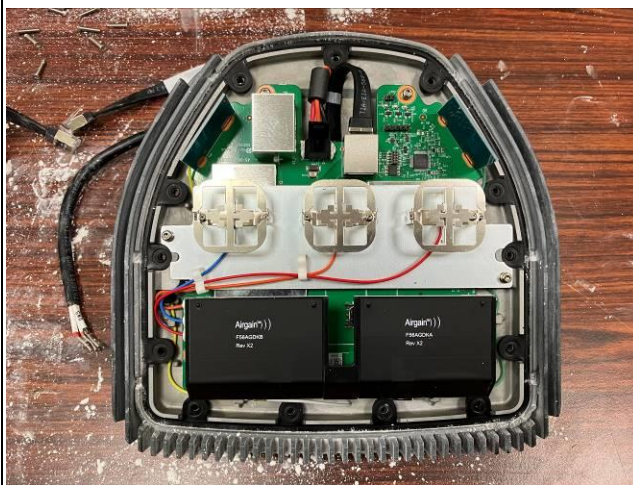
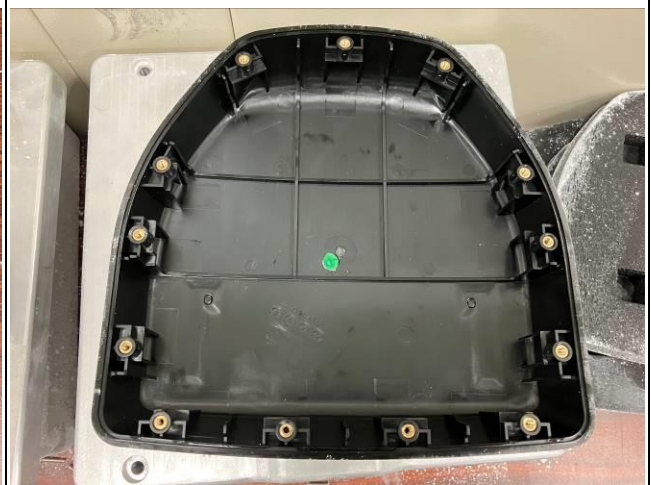
3131

After testing

The appearance of unit was normal (No dust particle permeate into inner of the unit)

After testing, visual inspection showed that no dust particle permeated into units.

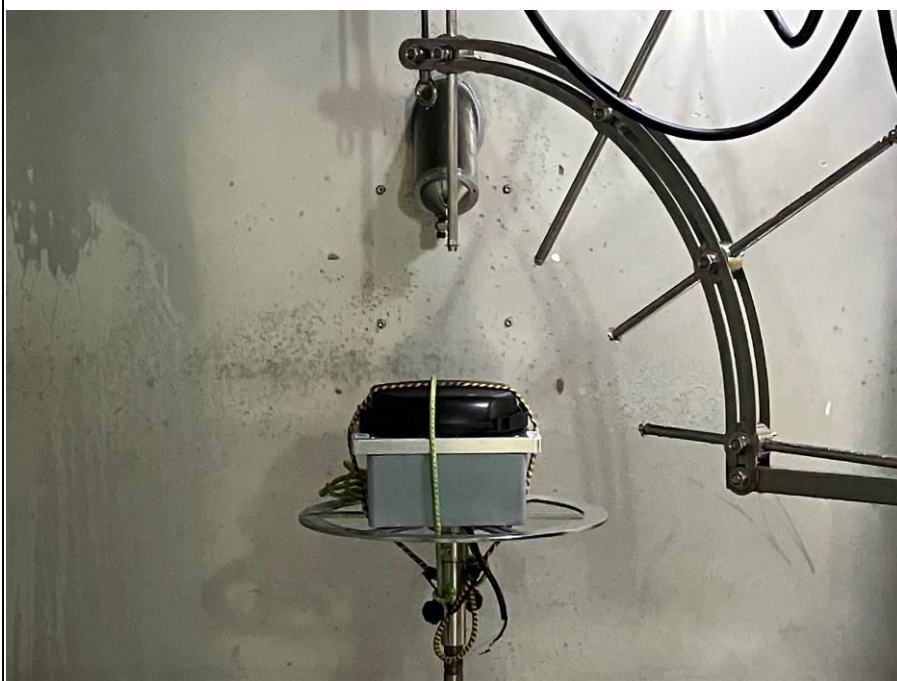
Setup

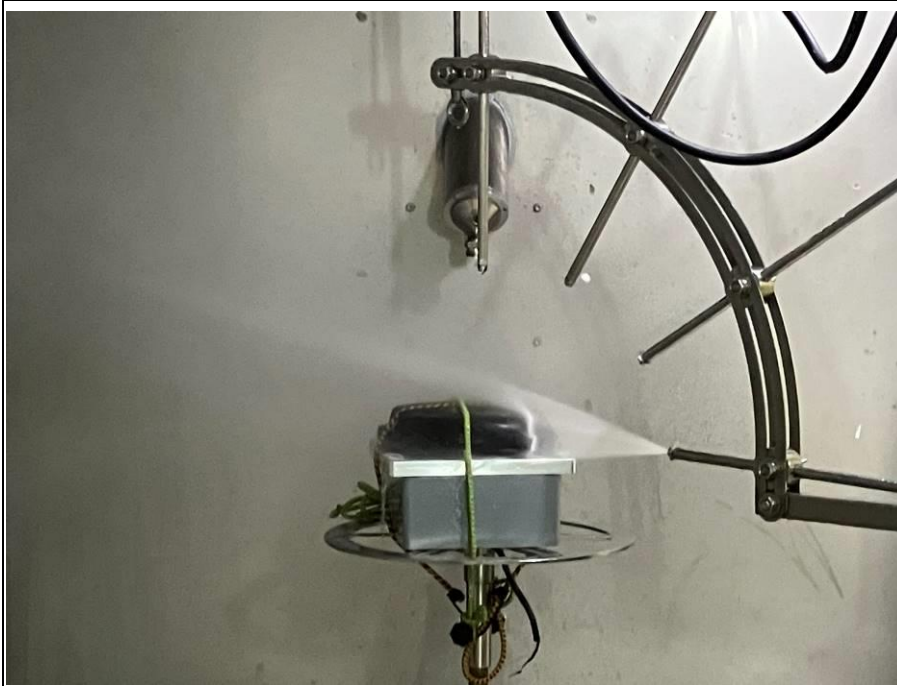
During testing

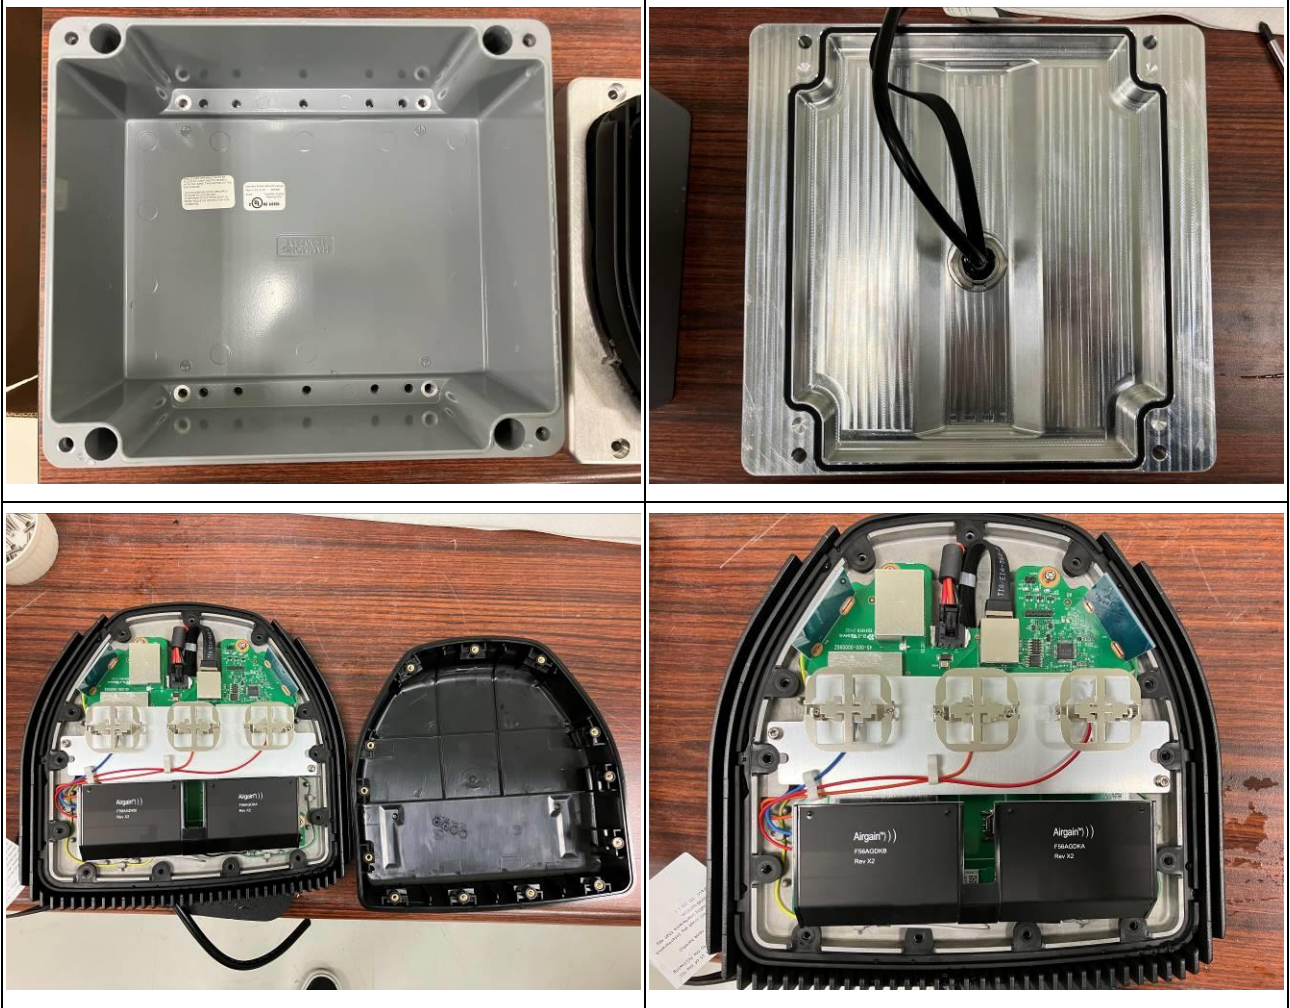
3131

After testing

The appearance of unit was normal (No water permeate into inner of the unit)

3.5.1 After testing, visual inspection showed that no water permeated into units. (The inner unit was dry)

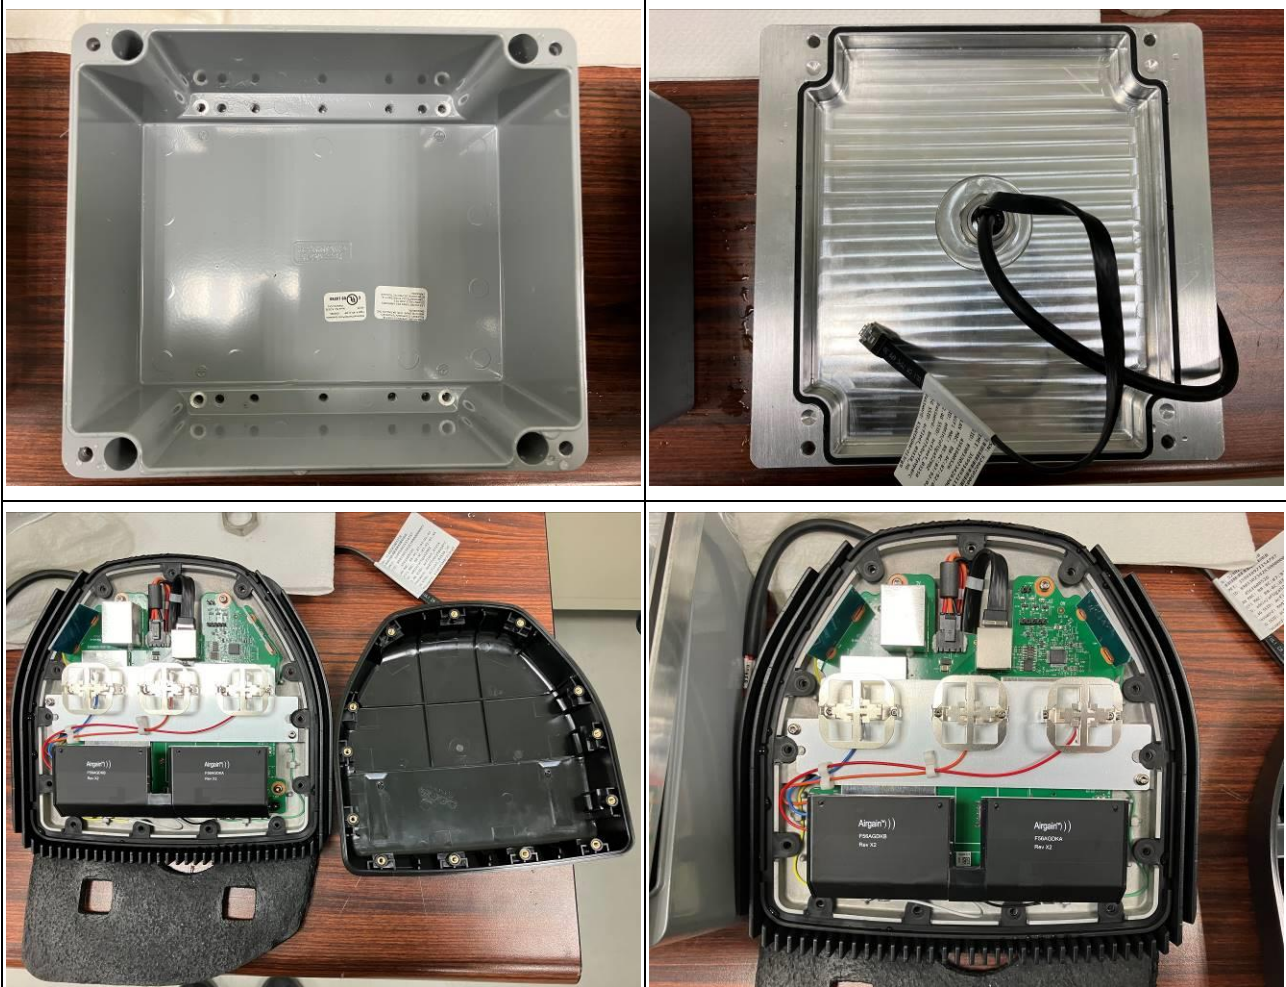
3158

After testing

The appearance of unit was normal (No water permeate into inner of the unit)
