# Test Report

Report No. A2240340850101a

Sample Name RECON5 antenna

No.	Test Item
1	IP6X

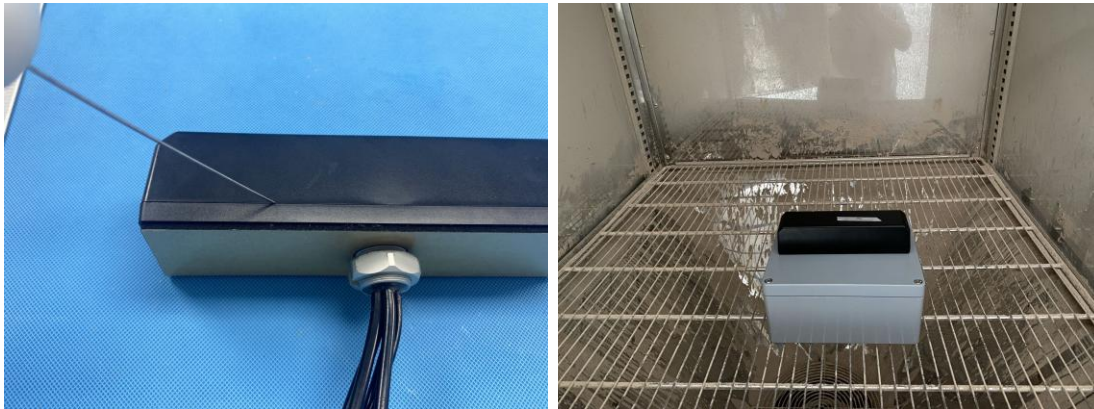
Test Photo(s)

--- Probe Test: The test prober of 1 mm diameter is pushed against any opening of the sample with force of 1 N.

Cycle as step -c) to step -d) listed above for 20 times.

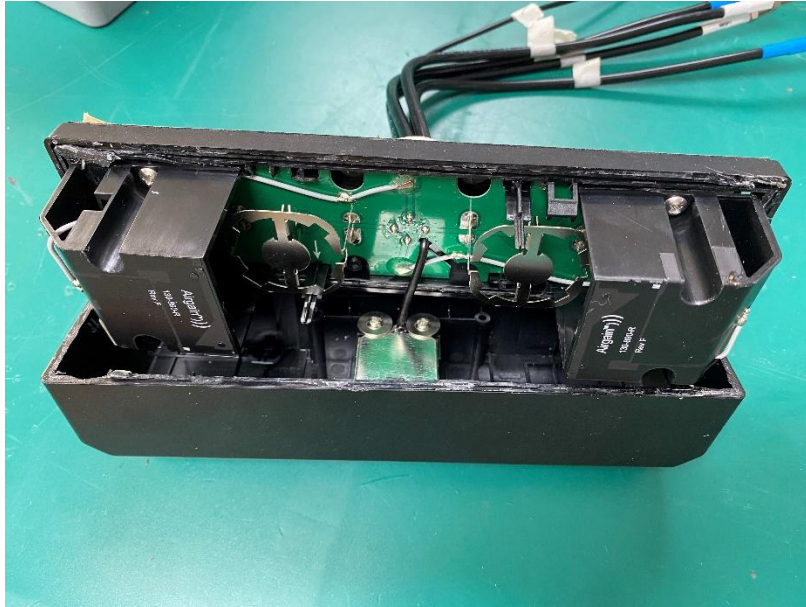
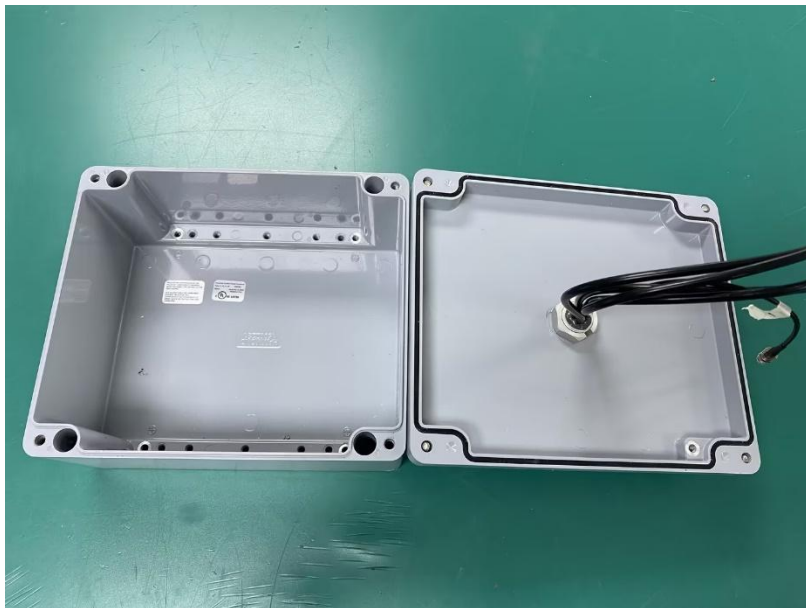
Sample No.	Result	Conclusion
A2240340850101001-1	Visual inspection, test probe cannot into the sample. No obvious dust was observed in the sample or NEMA enclosure after test.	Pass
