# Device Errata

## NL-SWDK2

NimbeLink Corp

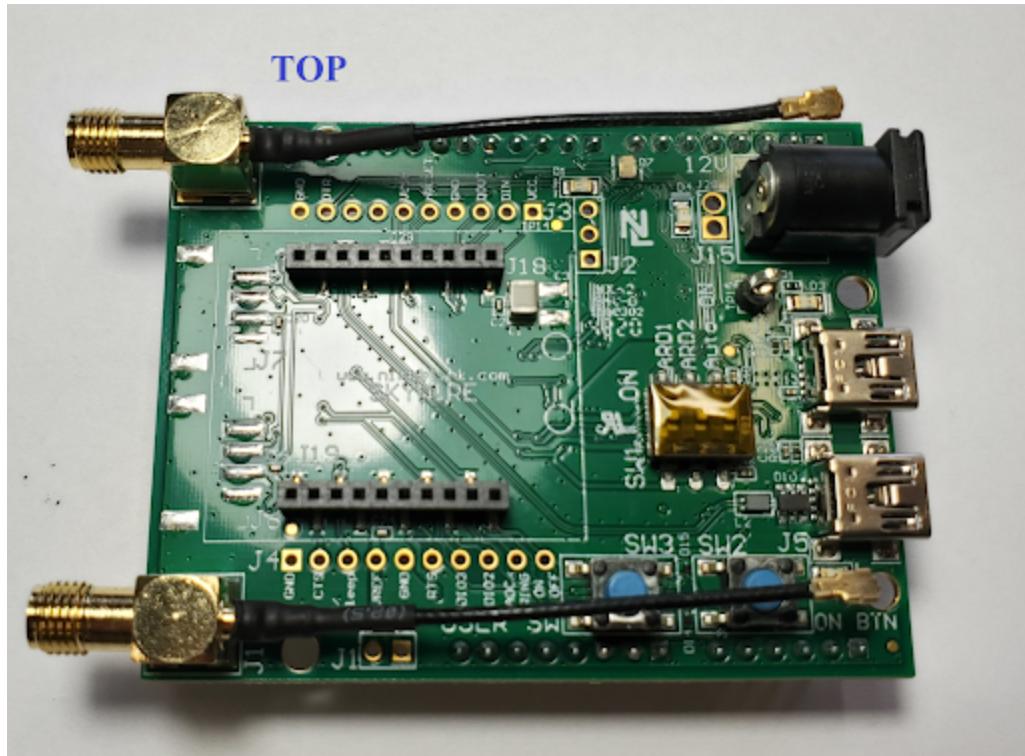
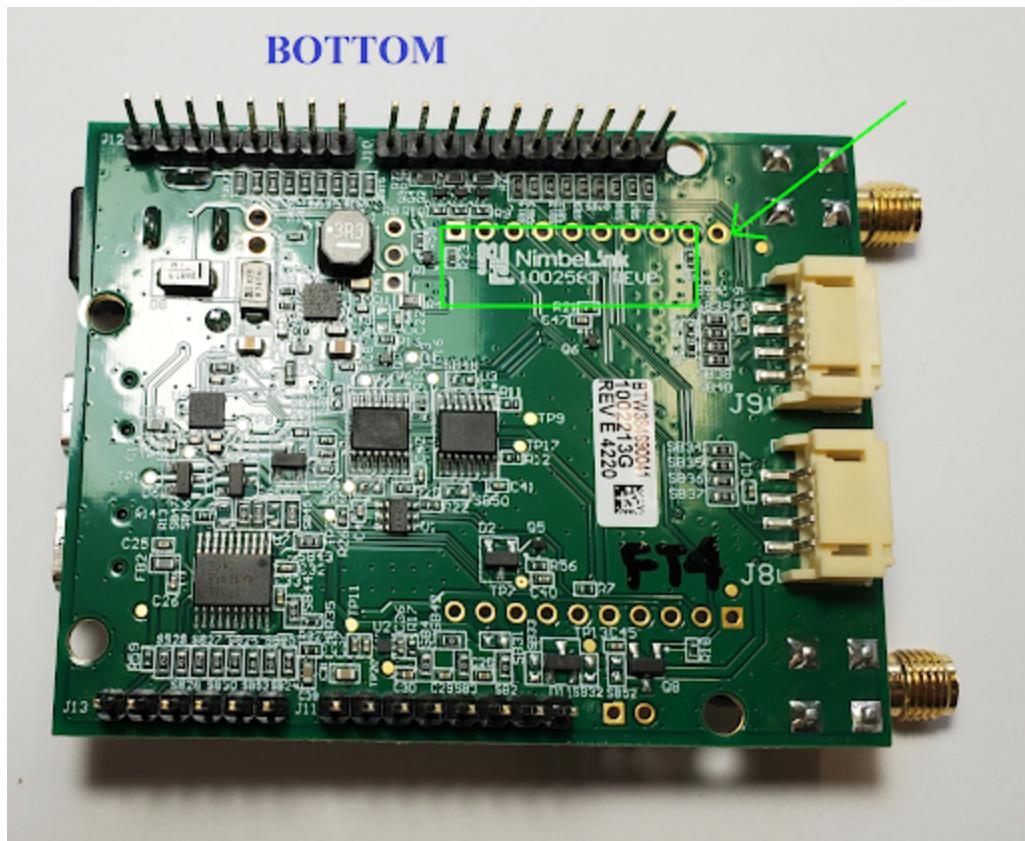
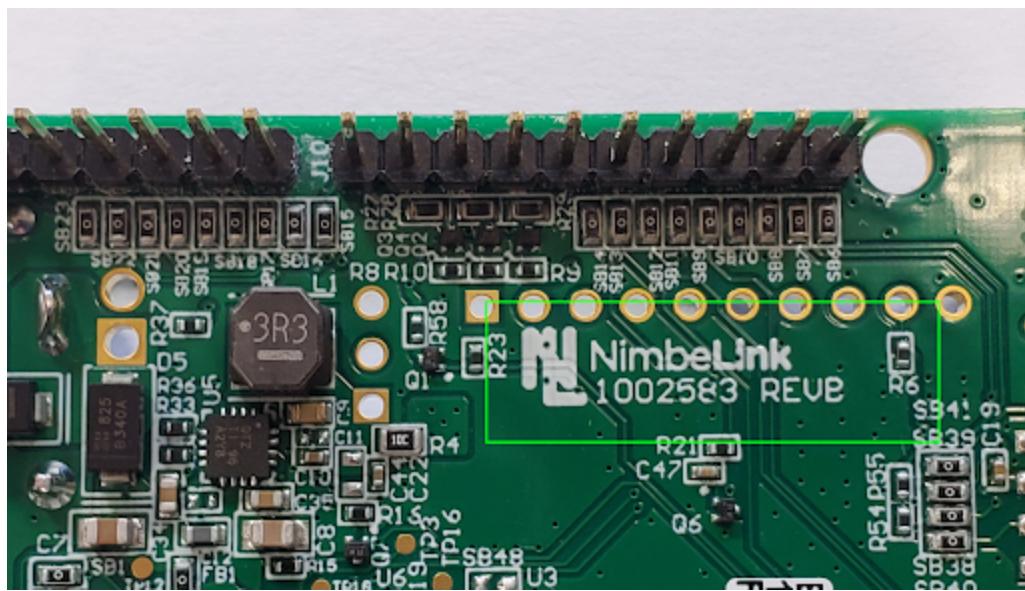
Affected devices can be identified by checking their part number on the devices PCB Silkscreen. All devices with part numbers 1002583 are affected. Check the bottom of the PCB to locate your assembly and revision number.

The assembly number is shown in the image above, inside of the green box.

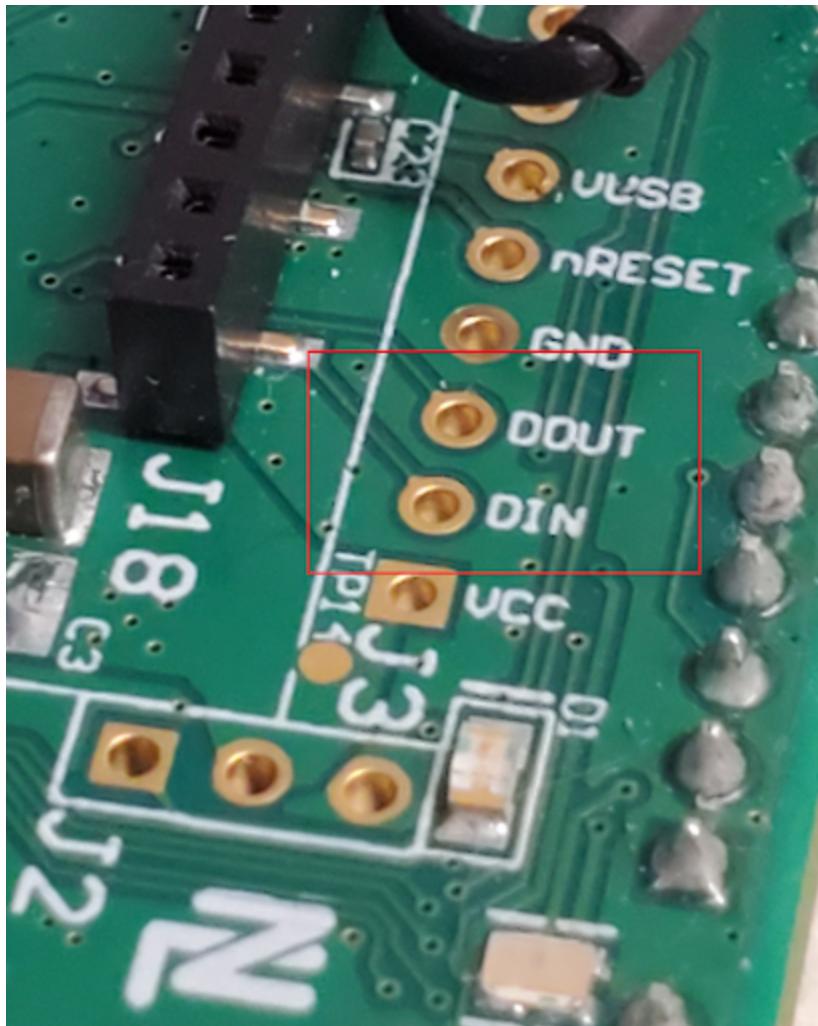
This Errata affects the NL-SWDK2 on the J3 through-hole header. The silkscreen labels for DOUT and DIN are swapped. DOUT should be DIN and vice versa. **Please note:** The electrical copper connections are still correct and the board is fully functional. Only the silkscreen is incorrect.

The silkscreen labels for DOUT and DIN are swapped on the J3 connector. DOUT should be DIN and vice versa.

Please refer to the SWDK2 schematic for the correct pinout of the J3 header
